# Inspection report for the property at 4000 Example Rd, Anytown, VA 22193

This report is prepared exclusively for **New Client**  
Inspected On: **05-21-2026**

Westwood Inspections LLC  
703-994-8736

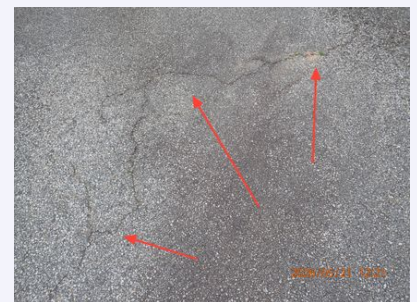
**📌 FYI: DRIVEWAY:**

- Cracks Present

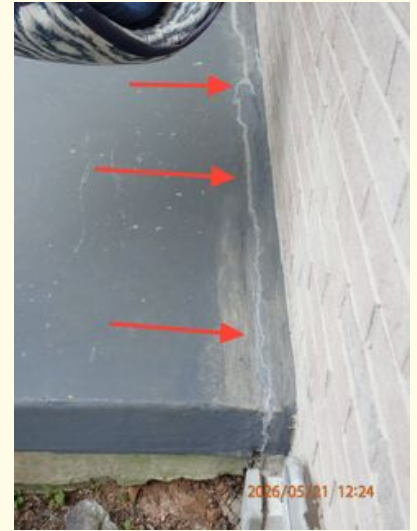
**🔧 (LAG-4) Repair: PORCH/STEPS:**

- Settlement noted
- Heavily cracked
- Repair recommended

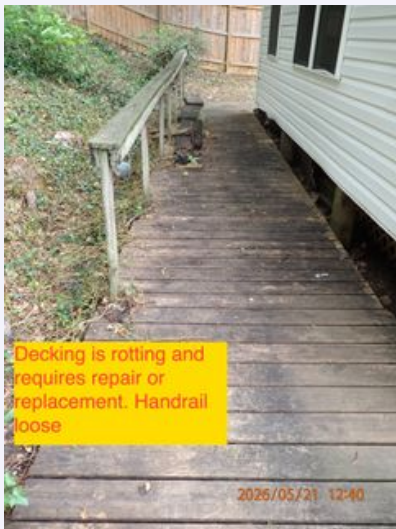
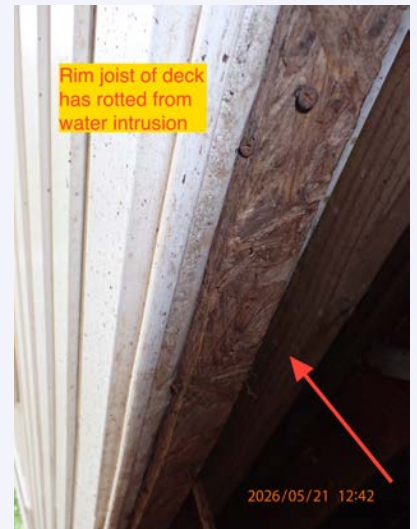
**FYI: DECK:**

- Repair or replacement recommended
- Rotted/broken board in deck needs replaced
- Lattice under deck is in disrepair and not fully attached.

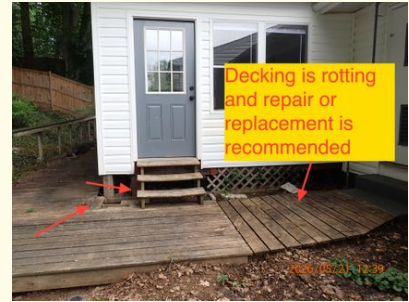
**DECK RAILS AND STEPS:**

- Open stair risers present. For improved safety, recommend corrections to not allow passage of a 4-inch diameter sphere
- Recommend adding rail for safety
- Repair recommended

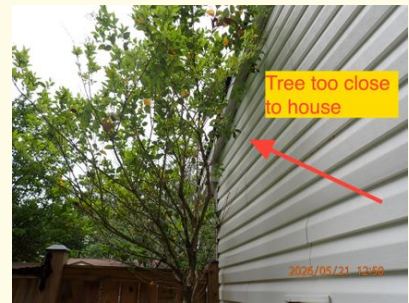
**TREES AND VEGETATION:**

- Tree planted too near the foundation and roots may cause damage to the foundation
- Trees planted too close to structure, removal may be required

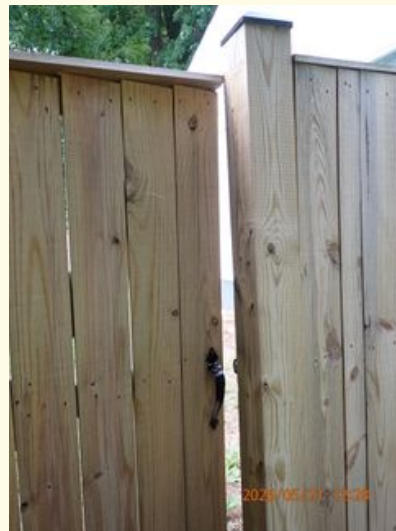
**(LAG-3) Repair: FENCE:**

- Gate misaligned and will not latch properly.

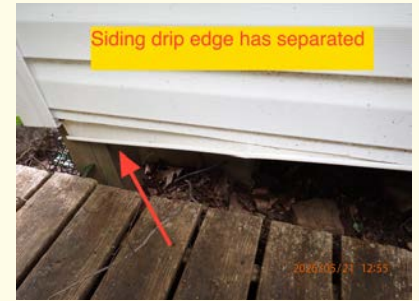
### 🔧 (E1-3) Repair: **SIDING:**

- Cracks present
- Repair recommended
- Loose vinyl on side of home, Recommend repair

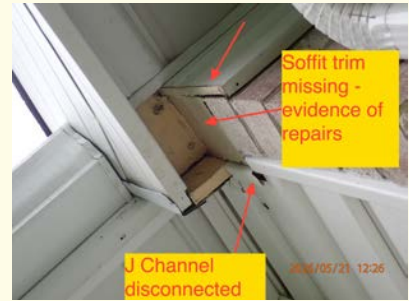
**(E1-5) Repair:**

- Damaged
- Missing trim
- Repairs Recommended

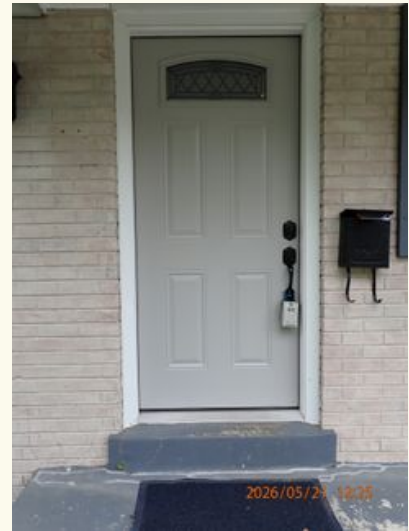
**DOOR BELL:**

- No doorbell present.
- Recommend installing doorbell

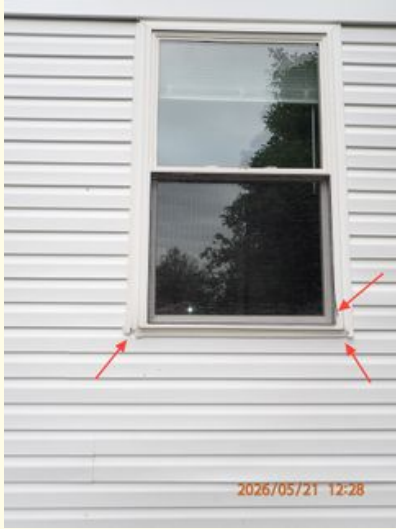
**(E1-1) Repair: WINDOWS:**

- Visible damage on window framework
- A qualified contractor is recommended to evaluate and estimate repairs

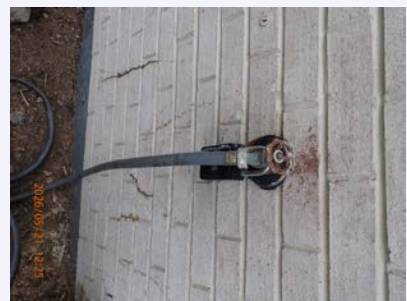
**HOSE BIB:**

- Non-Frost free faucet
- Recommend replacement with frost free anti-siphon hose bib to prevent back flow and protect from freezing.

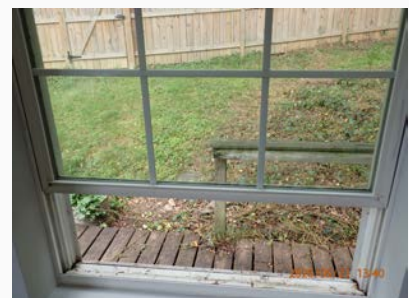
**WINDOW SCREENS PHOTO(S):**

- Recommend adding screens where missing
- Screen is torn and will need repair
- Virginia building requirement is that every door, window and other outside opening required for ventilation purposes shall be supplied with approved tightly fitted screens of not less than 16 mesh per inch (16 mesh per 25 mm), and every screen door used for insect control shall have a self-closing device.

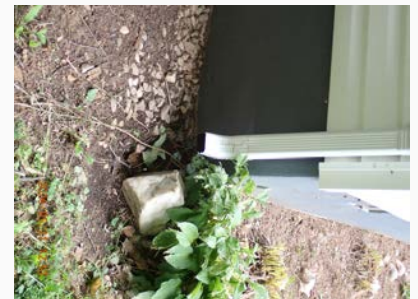
**GUTTER EXTENSION PHOTO(s):**

- Recommend adding extensions where missing
- Recommend replacing splash blocks with gutter extensions
- Recommend adding extensions to get water away from foundation

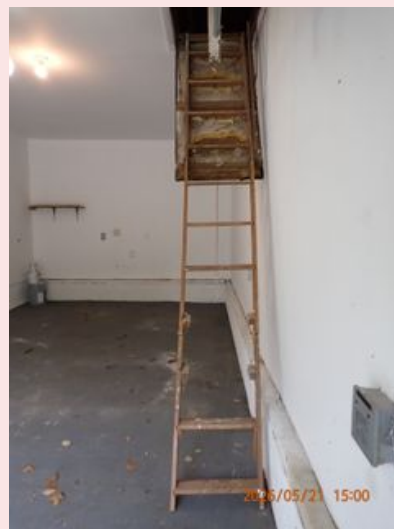
**(A-2) Safety/Health Hazard:** Attic access in garages should be made of fire rated material such as drywall, repairs are recommended. Attic access stairs are broken and require replacement.

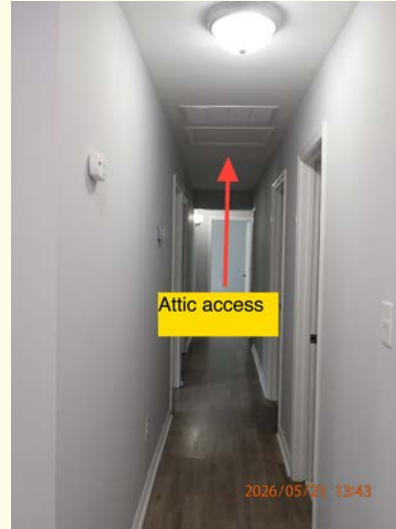
🔧 (A-6) Repair: **ATTIC ACCESS:**

- Attic hatch made of cement board. Replace with gypsum board or OSB.
- Attic hatch missing insulation on top and gaskets around seal.

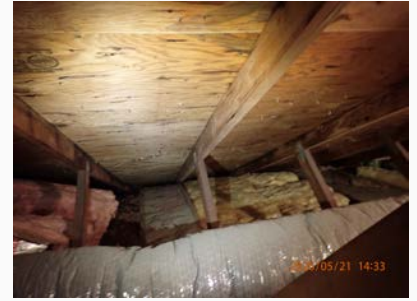
***SHEATHING PHOTO(s):***

- Water stains present
- Water damage present
- Wood rot present
- Sheathing will require replacement due to damage or wood rot
- A Qualified Contractor is recommended to evaluate and estimate repairs

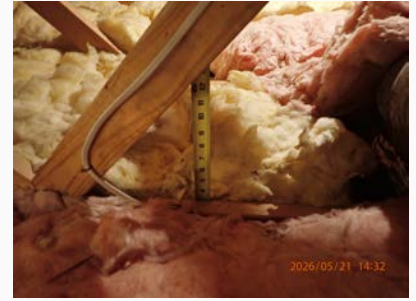
**INSULATION DEPTH PHOTO(S):**

- Insulation missing in areas, Recommend replacing insulation where needed
- Insufficient insulation present
- Recommend additional insulation be installed for energy efficiency

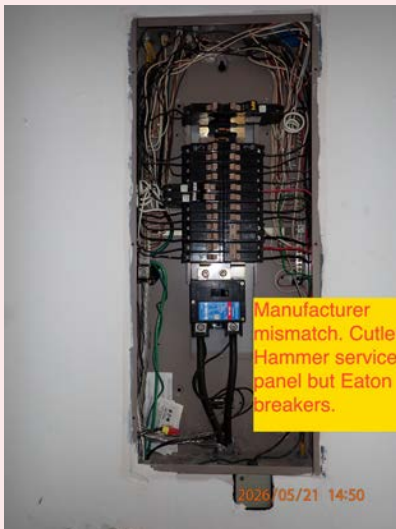
**⚠️ (EP-1) Defect/Major Concern: BREAKERS:**

- Double taps are present (multiple wires in one breaker). These wires need to be moved to their own circuit breaker, Recommended evaluation and repair by a licensed electrician
- Double tap wiring

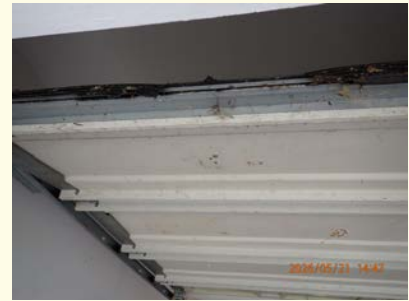
**(G-7) Repair:**  
**GARAGE DOORS:**

- Weather seal damaged

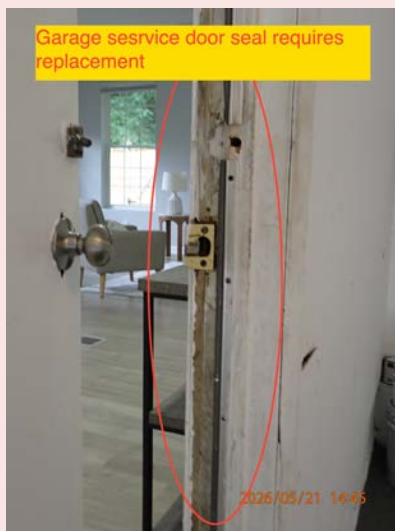
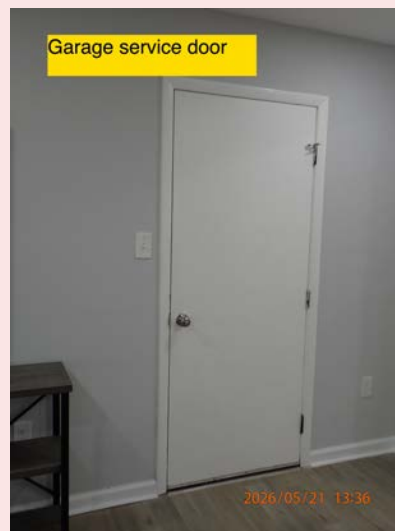
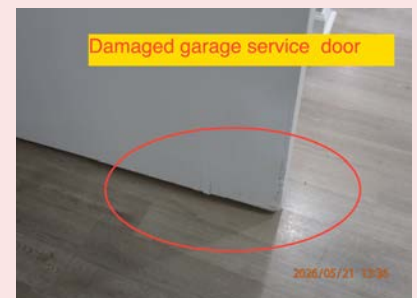
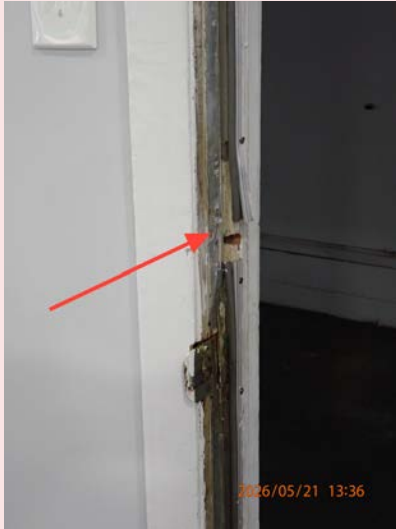
**(G-1) Safety/Health Hazard: GARAGE SERVICE DOOR:**

- Early stage water damage on door trim
- Missing and/or damaged door seals
- Repair Recommended

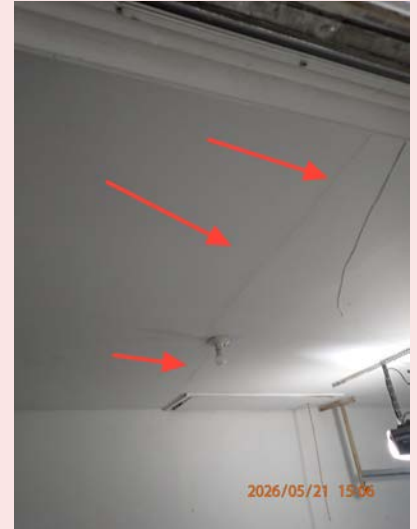
**(G-2) Safety/Health Hazard:** Penetrations are recommended to be sealed with fire rated sealant, repairs are recommended

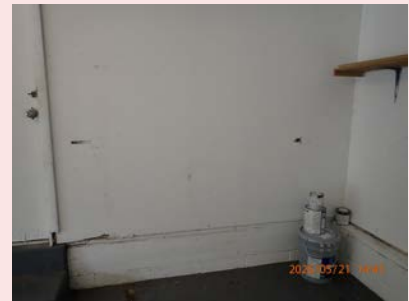
**⚠️ (G-3) Safety/Health Hazard:**

- Holes present
- Repair Recommended
- Penetrations not sealed creating a fire hazard.

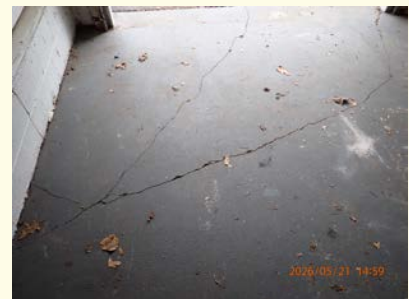
**🔧 (G-6) Repair:**

- Cracks present
- A Qualified Contractor is recommended to evaluate and estimate repairs

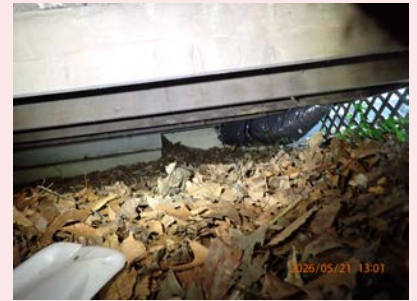
### ⚠️ (S-1) Defect/Major Concern: **JOIST/TRUSSES:**

- Floor in covered deck/living room area is sagging.
- Limited visibility of floor joists
- A Qualified Contractor is recommended to evaluate and estimate repairs

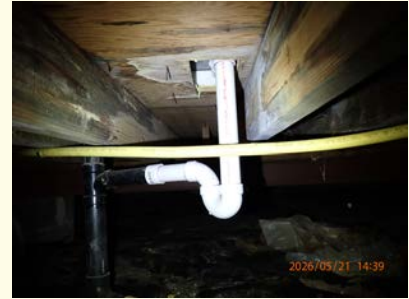
🔧 (S-2) Repair:

- Moisture damage under washing machine area

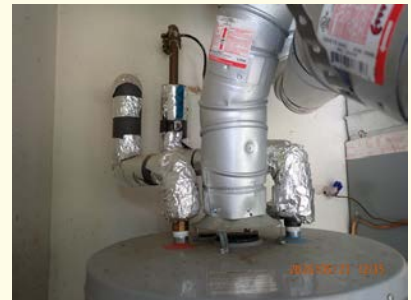
**(WH-1) Repair:**  
**EXPANSION TANK:**

- Recommend adding expansion tank

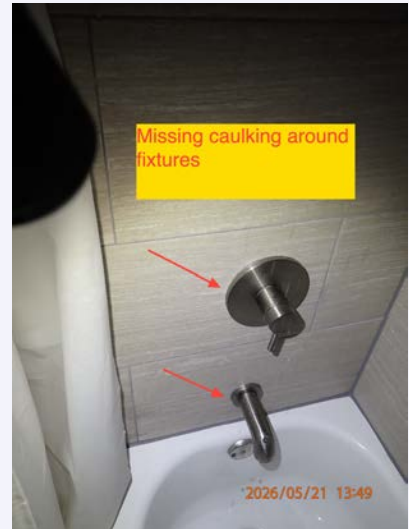
- Caulking missing from around shower handle and shower head fixtures.

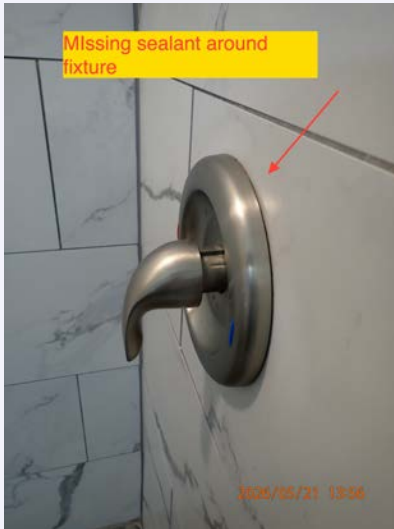
- Caulking missing from around shower handle and shower head fixtures.

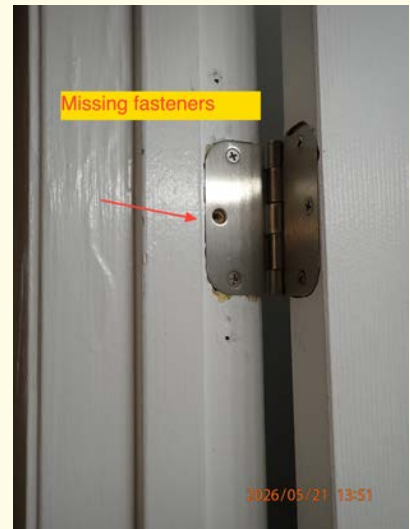
- Missing fasteners.

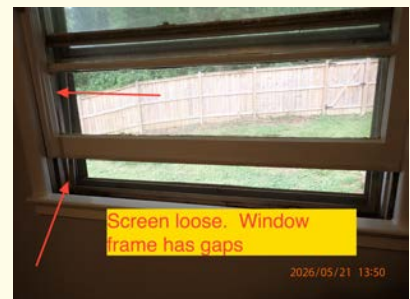
- Visible damage on window framework
- Recommend Repair

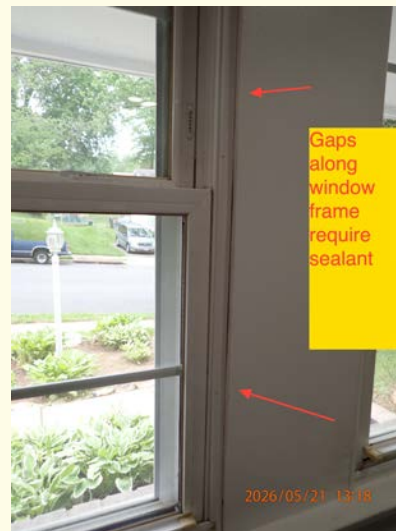
- Visible damage on window framework
- Damaged frame(s)
- Recommend Repair
- Missing sealant in gaps around window frame.
- A qualified contractor is recommended to evaluate and estimate repairs

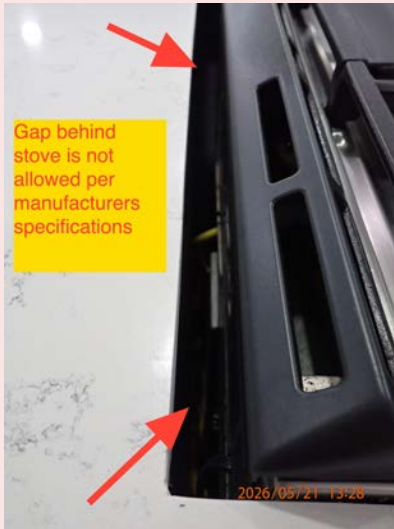
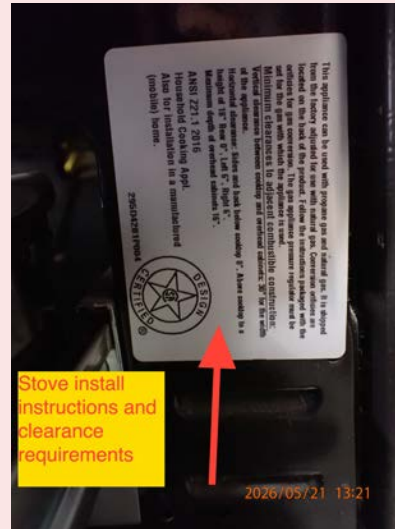
- Stove is not installed with clearance requirements specified by the manufacturer.
- A Qualified Contractor is recommended to evaluate and estimate repairs

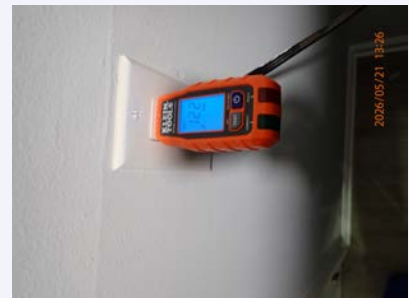
- Refrigerator is not on GFCI circuit.
