Inspection report for the property at

1300 Example Road

This report is prepared exclusively for **John Doe**
Inspected On: **01-19-2026**

73 year old two-story Colonial Revival style single-family residence, showcasing a mix of traditional American architectural elements. This was a homeowner requested maintenance inspection to identify wear and tear, safety concerns, and maintenance needs to help protect the owners investment year-round.

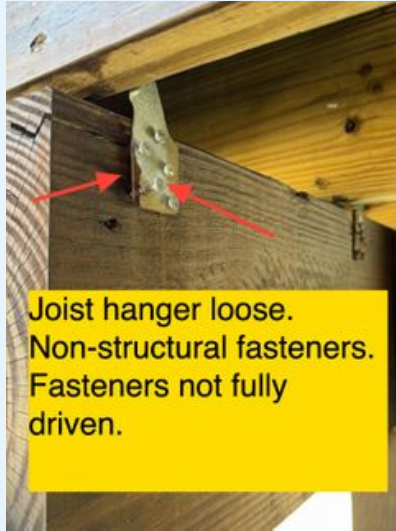
Joist hanger loose. Non-structural fasteners. Fasteners not fully driven.

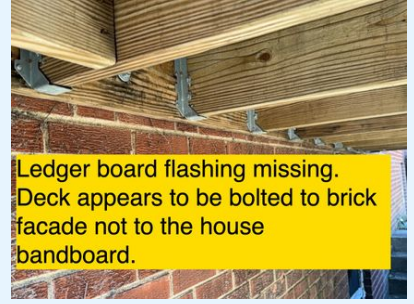
Ledger board flashing missing. Deck appears to be bolted to brick facade not to the house bandboard.

- Recommend further evaluation and estimate to bring deck up to an acceptable building standard.
- A qualified contractor is recommended to evaluate and estimate repairs
- Ledger board flashing missing.
- Deck appears to be attached to brick veneer and not the house band board. This could be a safety issue.

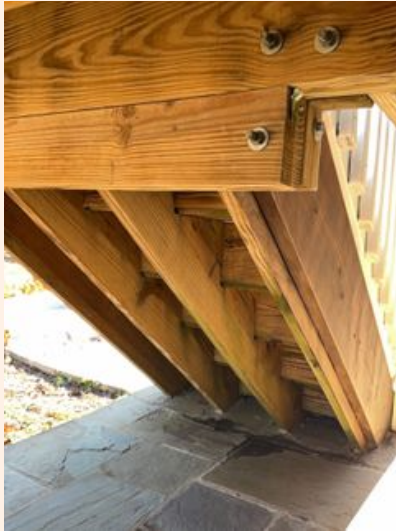
Deck post base is rotted and loose at base

- Repair recommended

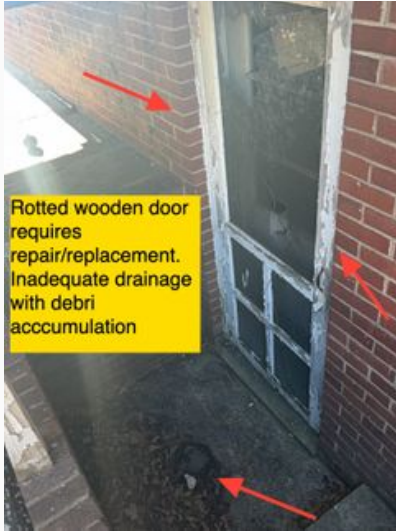
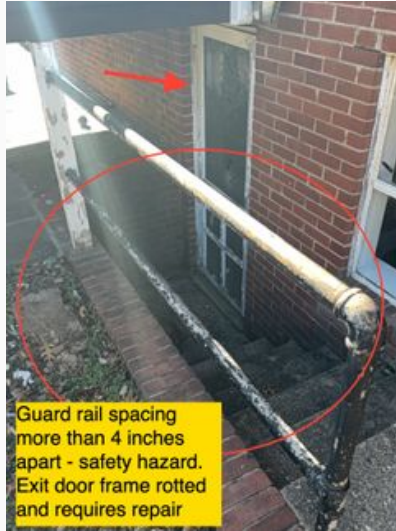
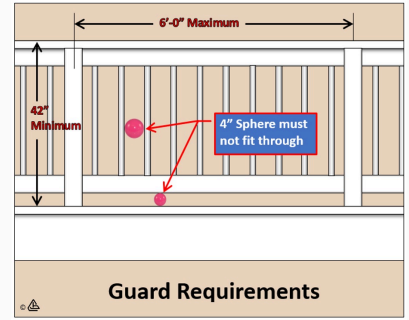
🔧 (E1-3) Repair: EXTERIOR DOOR:

- A qualified contractor is recommended to evaluate and estimate repairs
- Paint peeling
- Water damage on door trim
- Exterior wooden door is rotted and will not open close properly. .

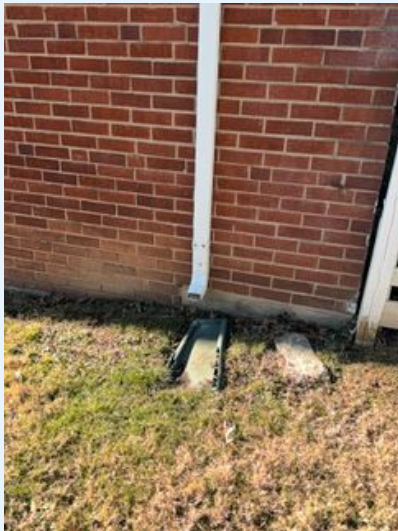
🔧 (R-2) Repair: GUTTER EXTENSIONS:

🔧 Gutter extension should extend at least 5 feet away from house to prevent water penetration and pooling against foundation. Evidence of water pooling and splashing against foundation and wall.

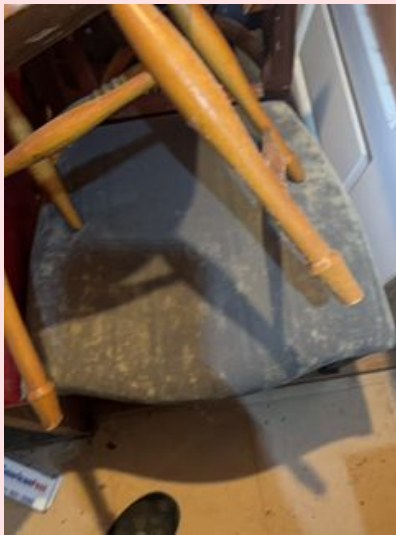
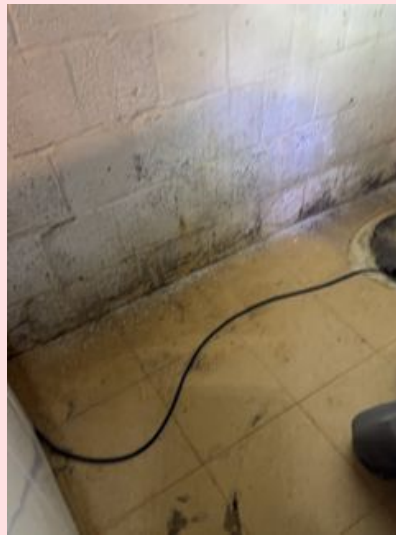
(S-1) Defective/Major Concern: **EVIDENCE OF FUNGUS:**

Fungus/Crawl Space: Fungus noted on many floor joists and beams

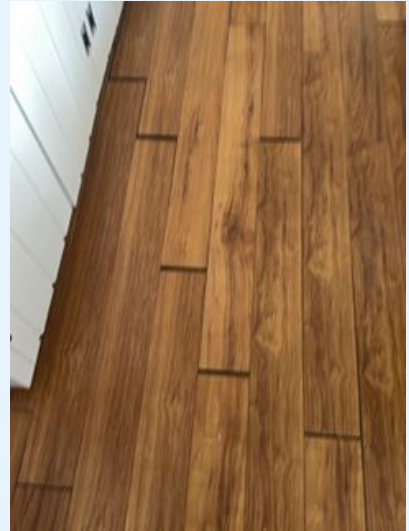
🔧 (B1-1) Repair:
BASEMENT FLOOR:

- Repairs Recommended
- A Qualified Contractor is recommended to evaluate and estimate repairs
- Flooring not installed properly with large gaps between floor planks.

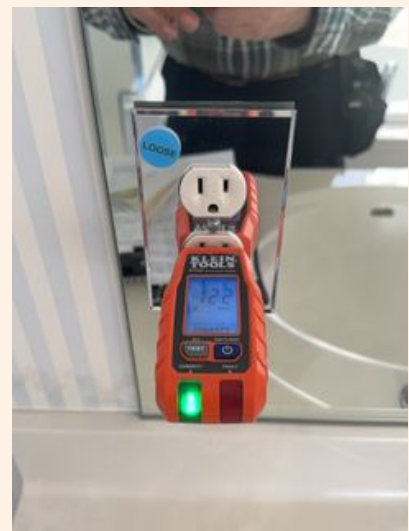
⚠ (B2-1) Safety/Health Concern:

Non GFCI protected circuit noted, A licensed electrician is recommended to evaluate and repair

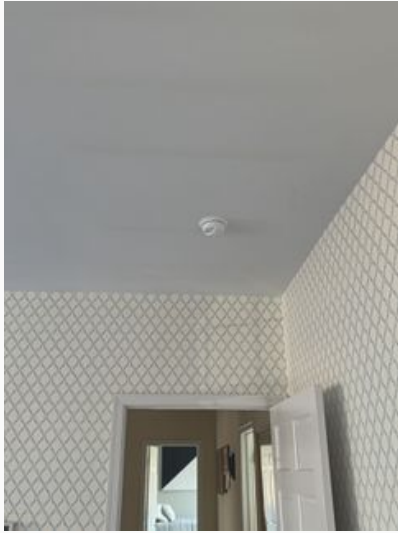
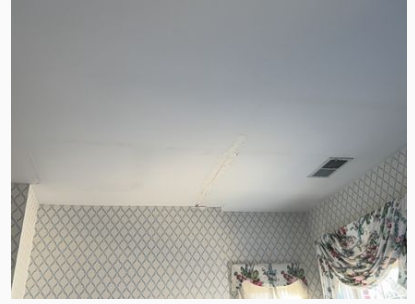
(B-1) Repair: **CEILING:**

- Water stains present, Dry at the time of the inspection
- Visible repair
- Loose tape joint
- A Qualified Contractor is recommended to evaluate and estimate repairs

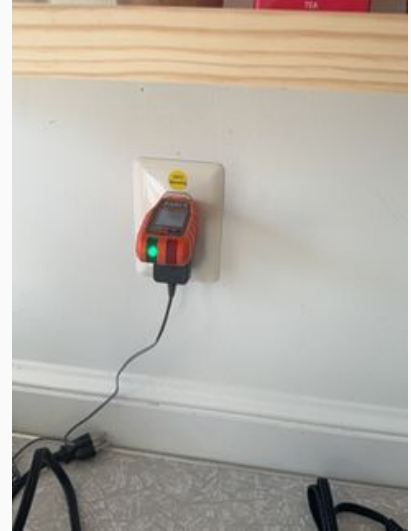
⚠️ (K-2) Safety/Health Concern: Non GFCI protected circuit noted, A licensed electrician is recommended to evaluate and repair

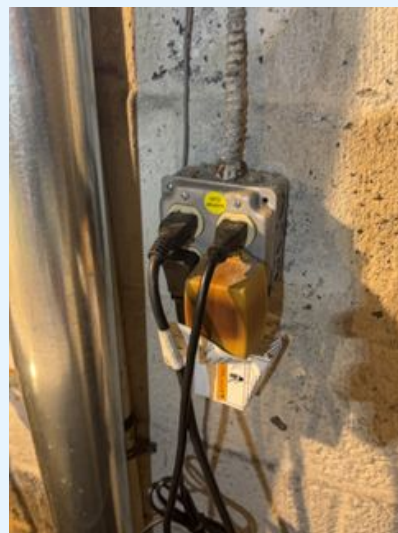
🔧 (LR-1) Repair:

Non GFCI protected circuit noted, A licensed electrician is recommended to evaluate and repair

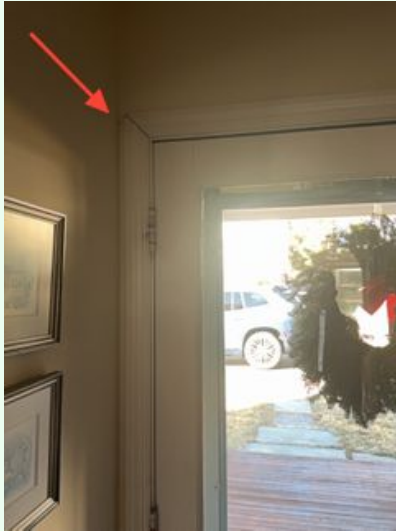
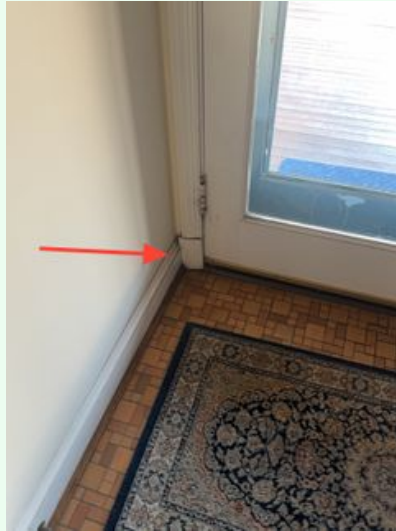
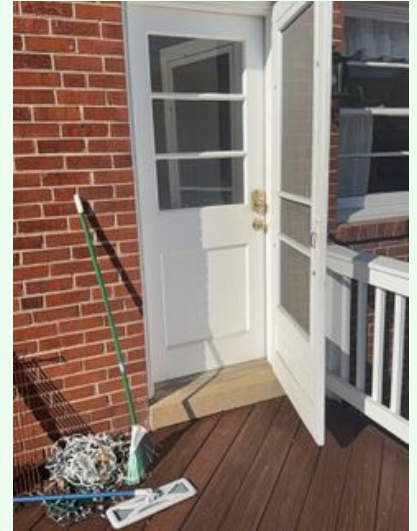
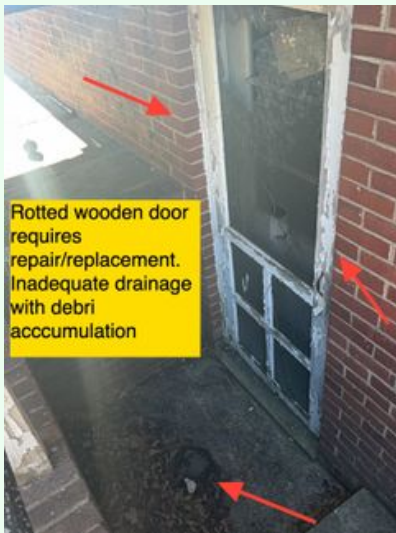
- Missing and/or damaged door seals
- Door, Not square in frame(s)
- Repair Recommended
- A qualified contractor is recommended to evaluate and estimate repairs
- Door, Not closing properly
- Water damage on door trim

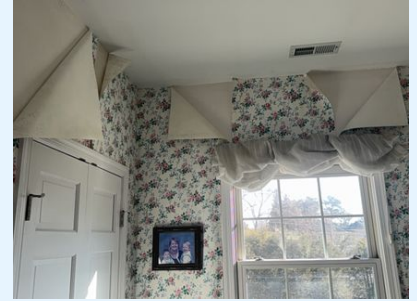
(IR-2) **Repair: WALL(s) ACTION ITEM(s):**

- Repair Recommended
- Wall paper peeling off.

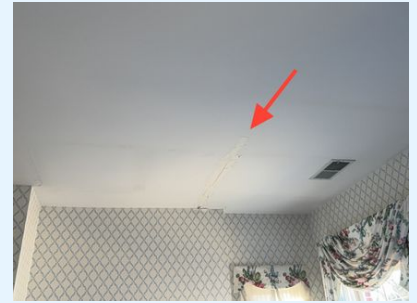
🔧 (IR-3) Repair: **CEILING:**

- Cracks present
- Visible repair
- Loose tape joint
- Water stains present, Dry at the time of the inspection
- Repair Recommended
- A Qualified Contractor is recommended to evaluate and estimate repairs

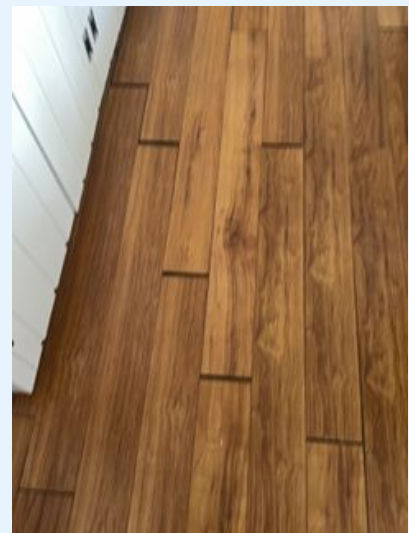
✦ (IR-4) Repair:

- A Qualified Contractor is recommended to evaluate and estimate repairs
- Repairs Recommended
- Vinyl tile floor not installed properly with gaps between planks.

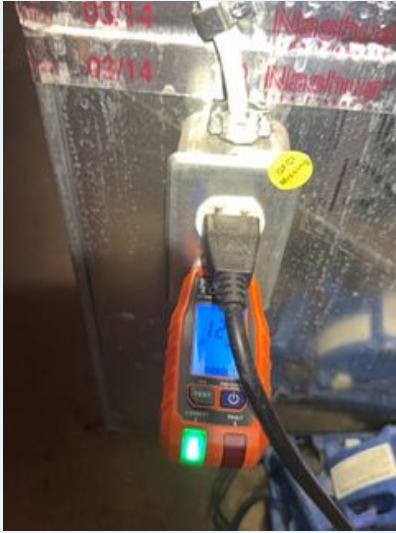
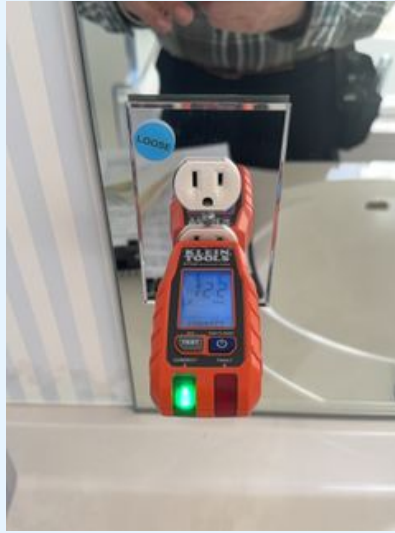
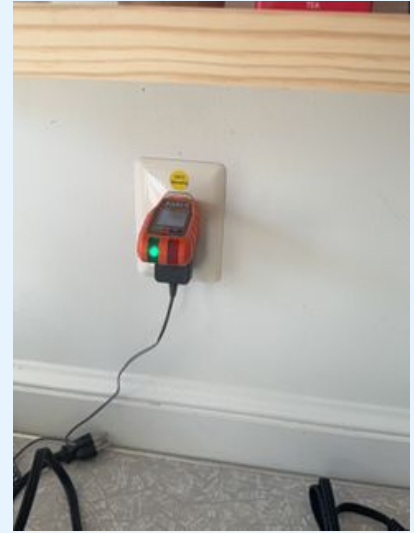
(IR-5) Repair: INTERIOR ELECTRICAL OUTLETS AND LIGHTS; ACTION ITEMS:

- Non-GFCI circuit, Recommend installing GFCI protected outlet
- Two prong outlet(s) present (Non grounded), typical for age of home
- Recommend evaluation by licensed electrician and estimate repairs

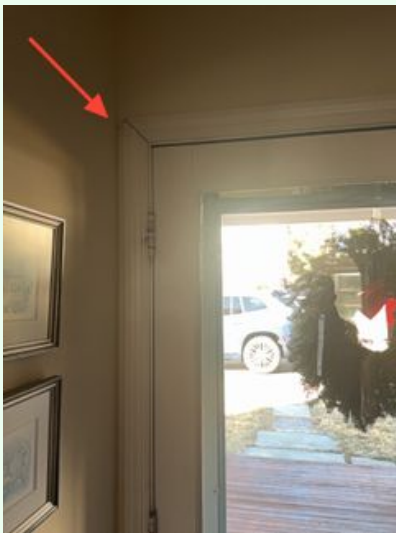
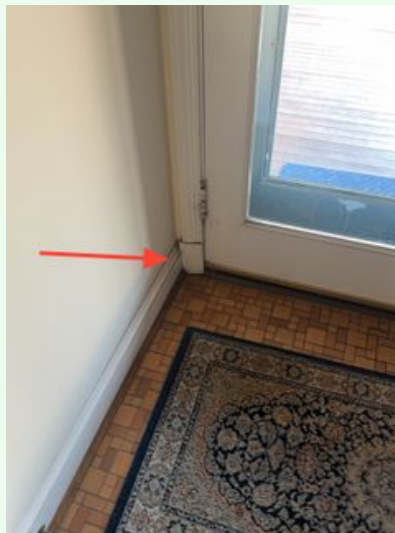
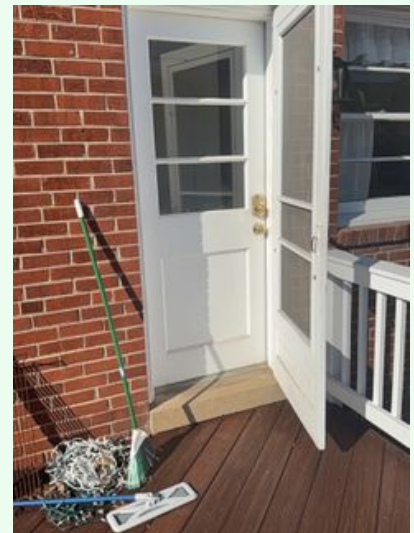
- Missing and/or damaged door seals
- Door, Not square in frame(s)
- Repair Recommended
- A qualified contractor is recommended to evaluate and estimate repairs
- Door, Not closing properly
- Water damage on door trim

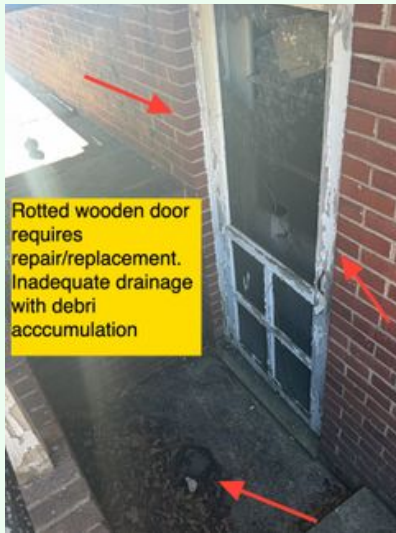
Rotted wooden door requires repair/replacement. Inadequate drainage with debris accumulation
