# Inspection report for the property at 4000 Example Rd, Anytown, VA 22193

This report is prepared exclusively for **New Client**  
Inspected On: **05-21-2026**

Westwood Inspections LLC  
703-994-8736

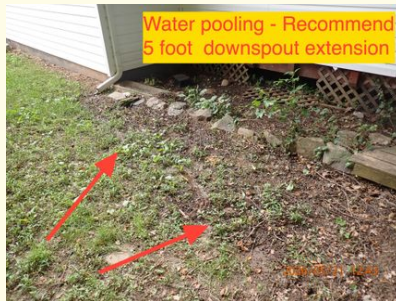
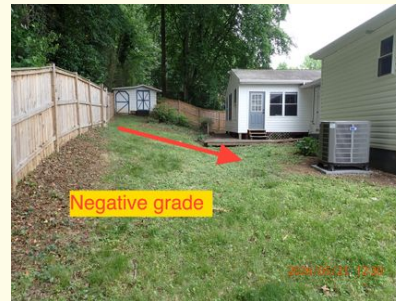
**🔧 (LAG-1) Repair: NEGATIVE GRADE:**

- Water from downspout pooling next to house
- Recommend improving grading to allow water to flow away from home by ensuring surface drainage is diverted to a storm sewer conveyance or other approved point of collection that does not create a hazard to the dwelling unit. It is recommended that lots be graded to drain surface water away from foundation walls. The grade should fall a minimum of 6 inches (152 mm) within the first 10 feet (3048 mm).
- Grading is allowing water to flow to crawlspace at rear of home

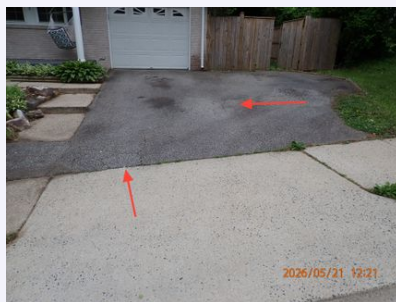
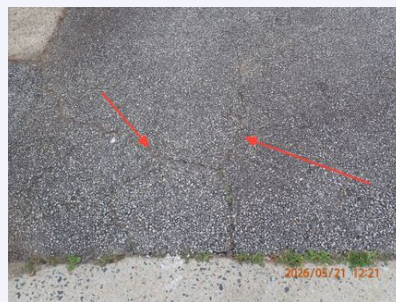
**📌 FYI: DRIVEWAY:**

- Cracks Present

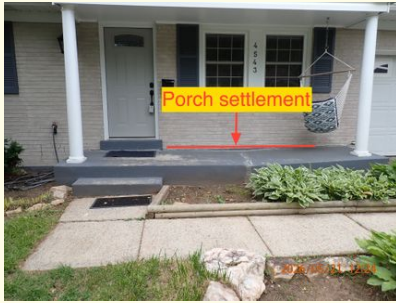
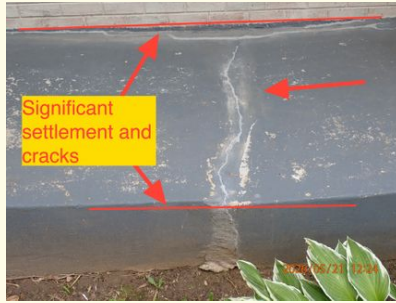
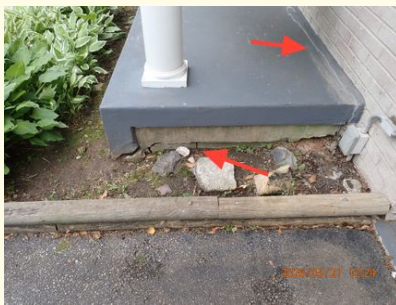
**🔧 (LAG-4) Repair: PORCH/STEPS:**

- Settlement noted
- Heavily cracked
- Repair recommended

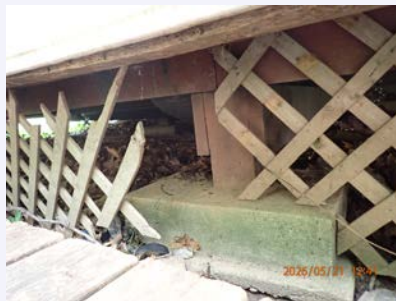
**FYI: DECK:**

- Repair or replacement recommended
- Rotted/broken board in deck needs replaced
- Lattice under deck is in disrepair and not fully attached.

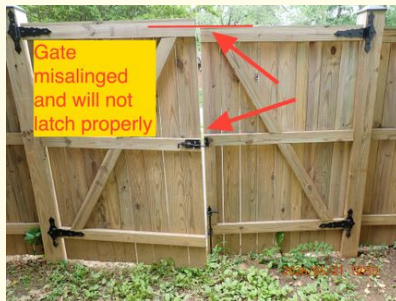
**(LAG-3) Repair: FENCE:**

- Gate misaligned and will not latch properly.

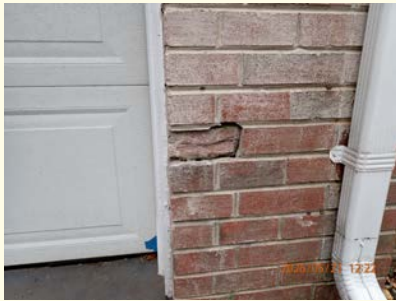
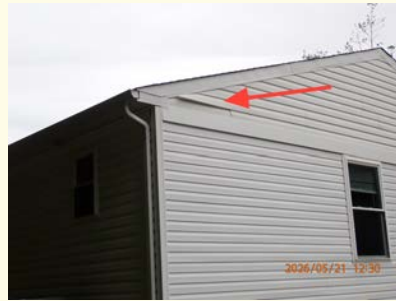
### 🔧 (E1-3) Repair: **SIDING:**

- Cracks present
- Repair recommended
- Loose vinyl on side of home, Recommend repair

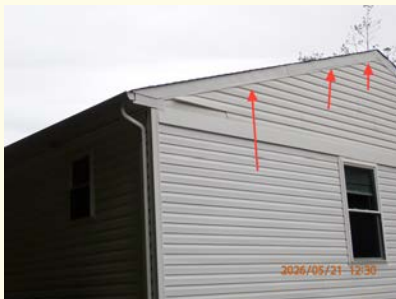
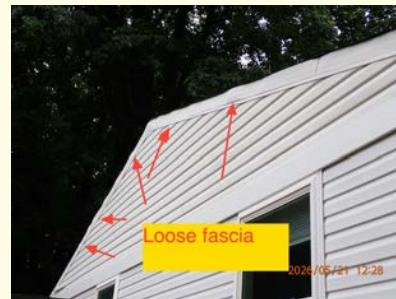
### 🔧 (E1-4) Repair: **FASCIA:**

- Repairs Recommended
- Loose

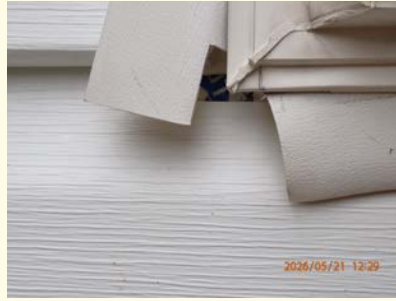
**(E1-1) Repair: WINDOWS:**

- Visible damage on window framework
- A qualified contractor is recommended to evaluate and estimate repairs

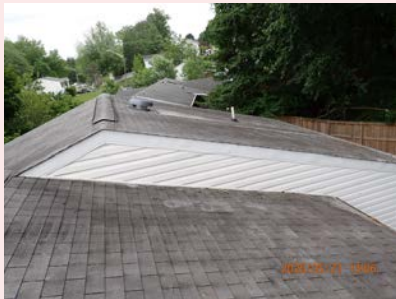
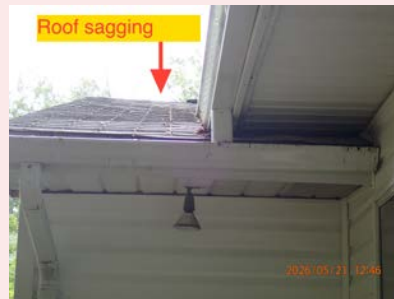
**⚠️ (R-1) Defect/Major Concern: ROOF SURFACE:**

- Standard 3-tab asphalt shingles typically last 15 to 20 years.
- Roof spongy to walk on
- Roof at end of useful life
- Moss on roof surface, This causes damage to shingles, Recommend removal or professional cleaning
- A qualified roofing contractor is recommended to evaluate and estimate repairs
- Loose or damaged shingles
- Replacement is recommended before closing

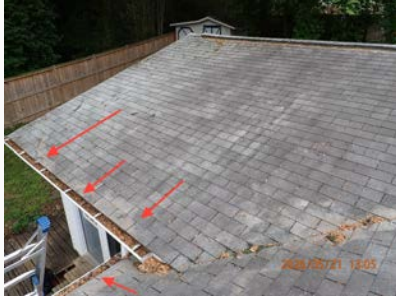
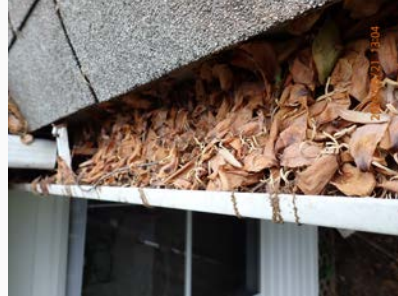
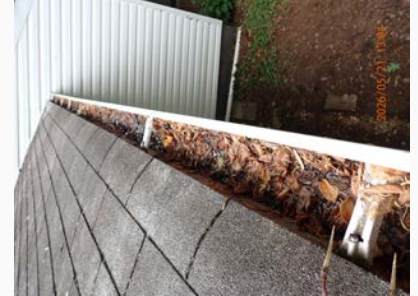
(R-2) Repair: **GUTTERS/DOWNSPOUTS:**

- Gutters need cleaning
- Gutters have negative flow and are holding water

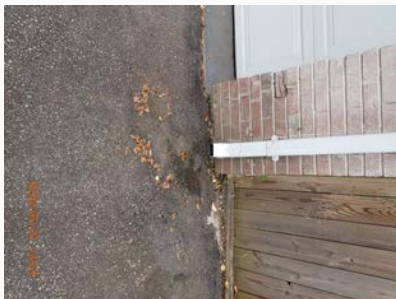
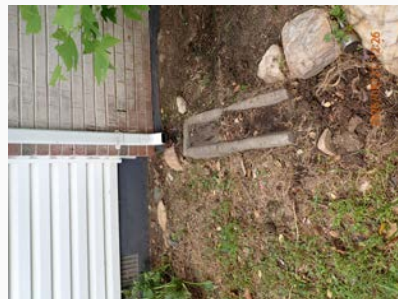
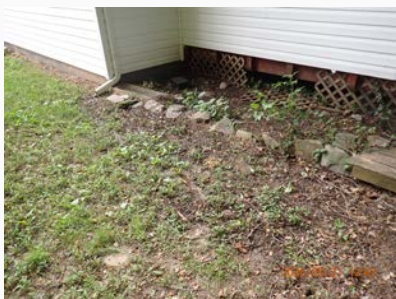
**(R-3) Repair: GUTTER EXTENSIONS:**

- Recommend adding extensions where missing
- Recommend replacing splash blocks with gutter extensions
- Recommend adding extensions to get water away from foundation

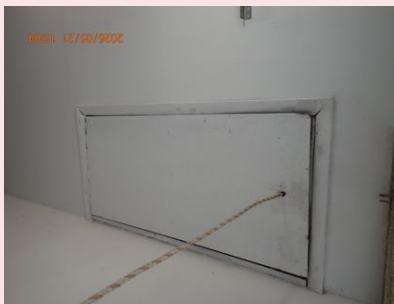
**(A-2) Safety/Health Hazard:** Attic access in garages should be made of fire rated material such as drywall, repairs are recommended. Attic access stairs are broken and require replacement.

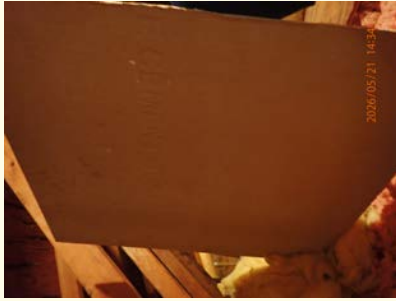
🔧 (A-6) Repair: **ATTIC ACCESS:**

- Attic hatch made of cement board. Replace with gypsum board or OSB.
- Attic hatch missing insulation on top and gaskets around seal.

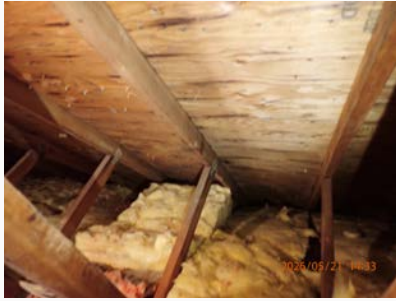
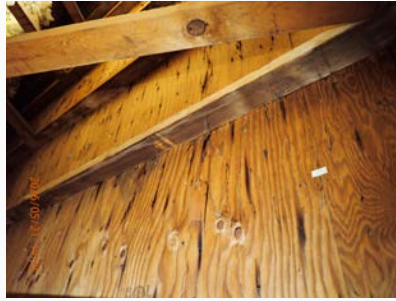
***SHEATHING PHOTO(s):***

⚠️ (A-1) Defect/Major Concern: **SHEATHING:**

- Water stains present
- Water damage present
- Wood rot present
- Sheathing will require replacement due to damage or wood rot
- A Qualified Contractor is recommended to evaluate and estimate repairs

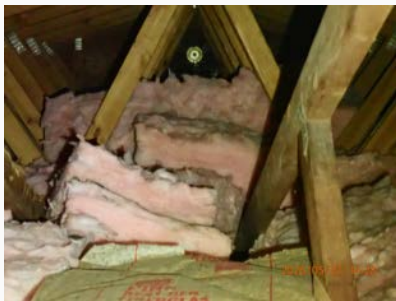
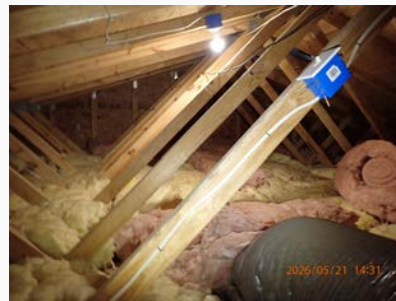
**INSULATION PHOTO(S):**

**(A-5) Repair: INSULATION DEPTH:**

- Insulation missing in areas, Recommend replacing insulation where needed
- Insufficient insulation present
- Recommend additional insulation be installed for energy efficiency

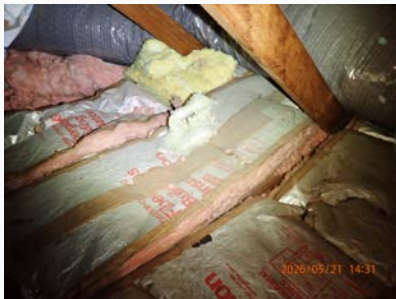
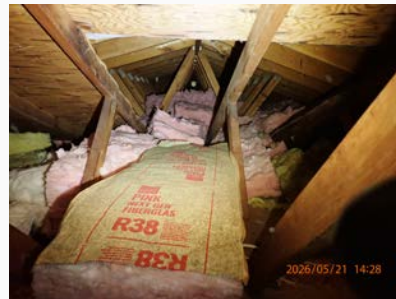
**VAPOR BARRIER PHOTO(S):**

**⚠️ (A-3) Safety/Health Hazard: VAPOR BARRIER:**

- Vapor barrier turned the wrong way on the insulation
- Recommend repair
- Insulation vapor barrier (kraft paper) must be facing and against conditioned space. Exposed vapor barrier is a fire hazard.

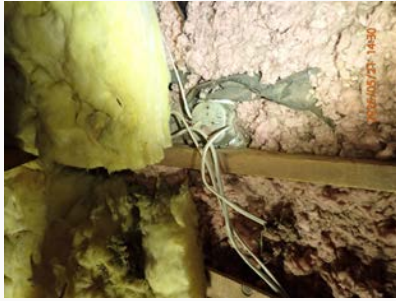
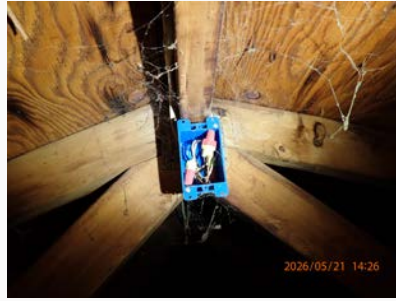
**WIRING/LIGHTING PHOTO(s):**

**⚠️ (A-4) Safety/Health Hazard: ATTIC WIRING:**

- Combustible insulation shall be separated not less than 3 inches (76 mm) from recessed luminaires, fan motors and other heat-producing devices.
- **Exception:** Where heat-producing devices are *listed* for lesser clearances, combustible insulation complying with the listing requirements shall be separated in accordance with the conditions stipulated in the listing.
- Exposed wiring
- Cover plate missing, Recommend adding cover plate

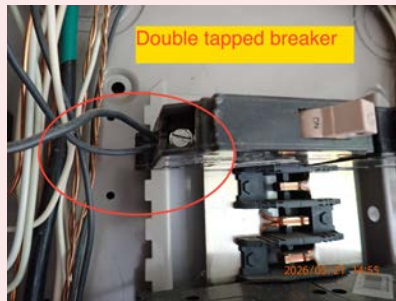
**⚠️ (EP-1) Defect/Major Concern: BREAKERS:**

- Double taps are present (multiple wires in one breaker). These wires need to be moved to their own circuit breaker, Recommended evaluation and repair by a licensed electrician
- Double tap wiring

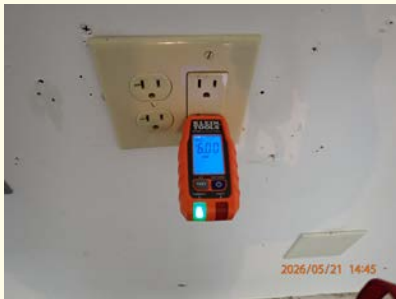
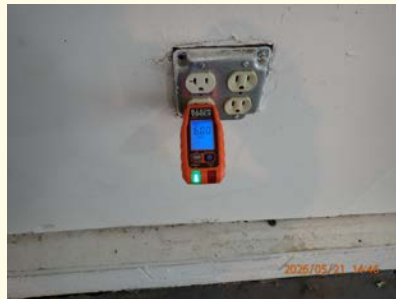
**(G-5) Repair: GARAGE ELECTRICAL:**

- Non-GFCI circuit, Recommend installing GFCI protected outlet

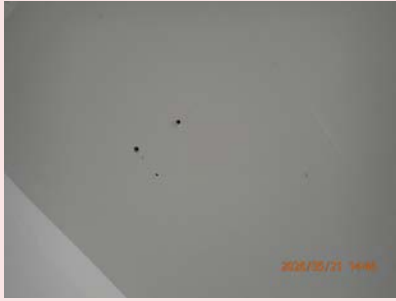
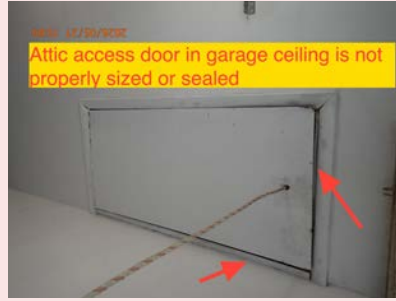
**(G-2) Safety/Health Hazard:** Penetrations are recommended to be sealed with fire rated sealant, repairs are recommended

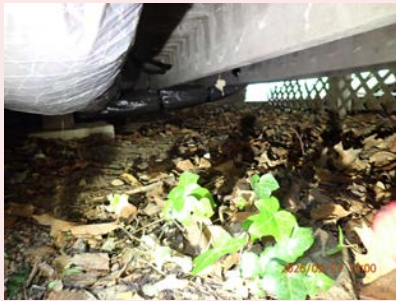
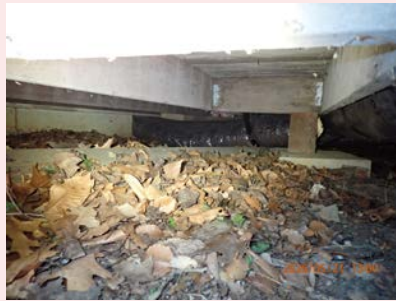
### ⚠️ (S-1) Defect/Major Concern: **JOIST/TRUSSES:**

- Floor in covered deck/living room area is sagging.
- Limited visibility of floor joists
- A Qualified Contractor is recommended to evaluate and estimate repairs

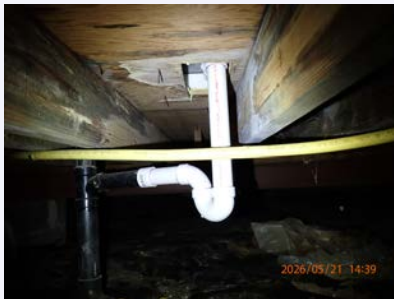
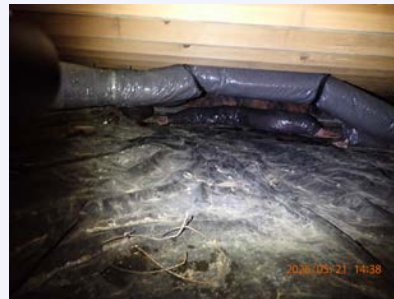
📌 **FYI: MOISTURE INTRUSION:**

- Dry at the time of the inspection
- Water stains present

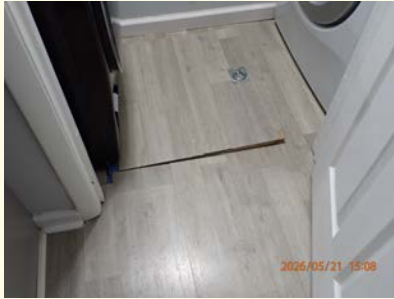
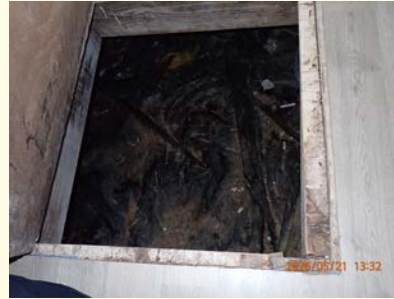
🔧 (CS-1) Repair: **CRAWL SPACE ACCESS:**

- Access hatch is not properly sized and will not close.
- Tripping/fall hazard.
- Recommend repairs

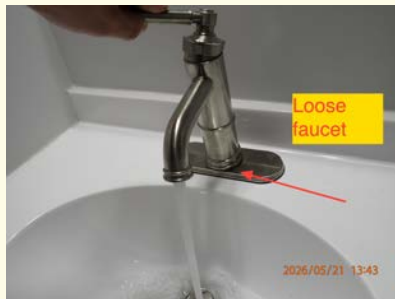
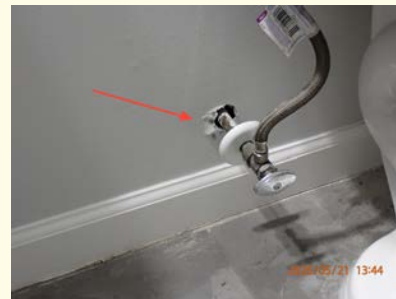
**FAUCET/TRAP PHOTO(s):**

🔧 (B2-3) Repair: **FAUCET/TRAP:**

- Surface rust on trap
- Faucet loose.
- Supply line not secured
- Unsealed wall penetration

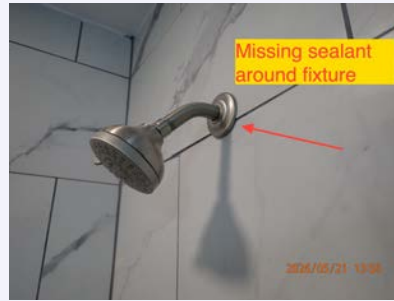
**FYI: SHOWER SURROUND:**

- Caulking missing from around shower handle and shower head fixtures.

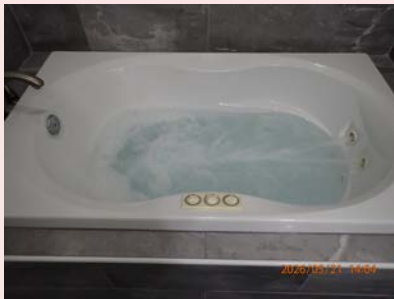
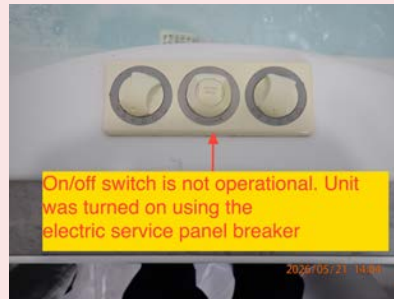
**⚠️ (B2-1) Safety/Health Hazard: SPA TUB:**

- No visible access panel
- On/off switch is not operating correctly.

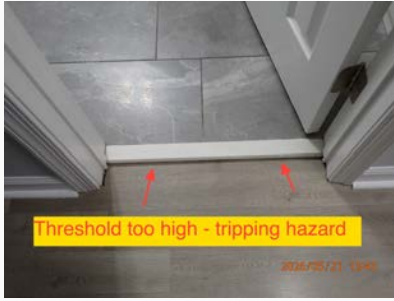
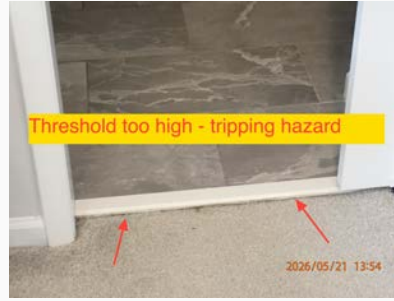
**FLOOR PHOTO(s):**

**🔧 (B2-4) Repair: FLOOR:**

- Threshold too high causing a tripping hazard.

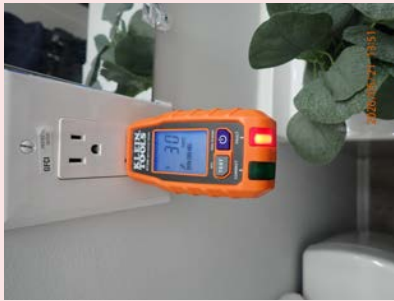
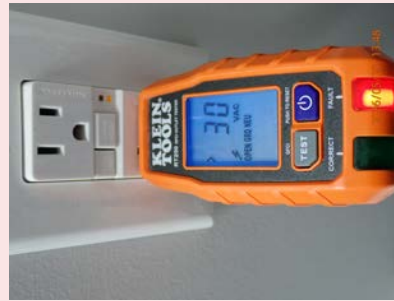
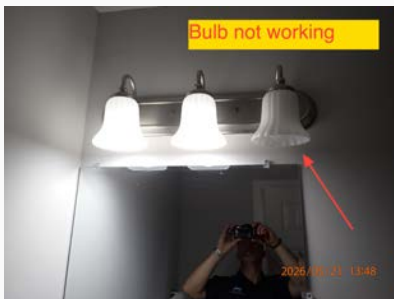
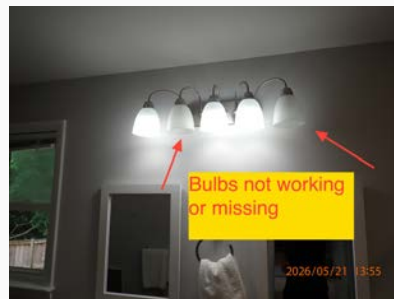
**ELECTRICAL PHOTO(S):**

**⚠️ (B2-2) Safety/Health Hazard: ELECTRICAL:**

- Open grounds noted at 3 prong outlets
- Recommend evaluation by licensed electrician and estimate repairs
- GFCI Outlet present but not working properly, Recommend repair or replacement

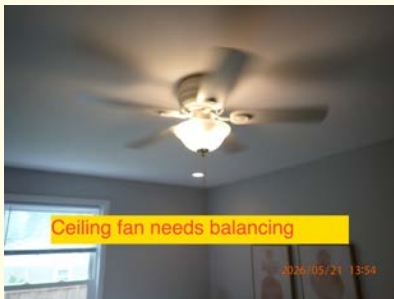
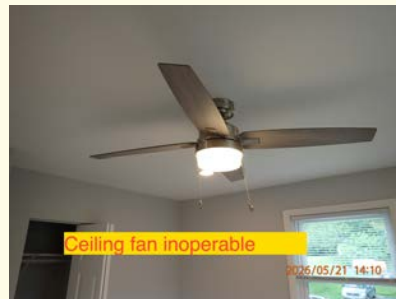
🔧 (B-2) Repair: **ELECTRICAL:**

- Ceiling fan needs balancing
- Ceiling fan inoperative, Possible hidden remote, Recommend having operational at walk through

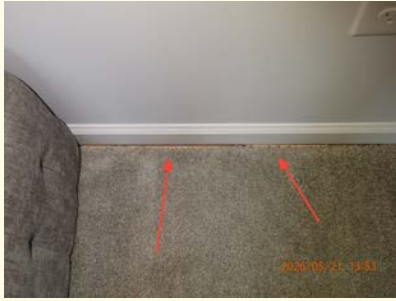
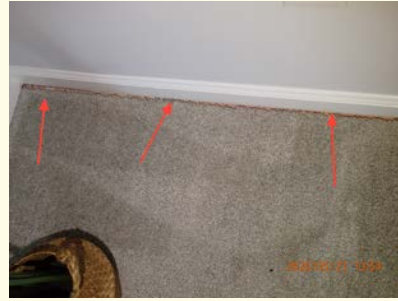
🔧 (B-3) Repair: **FLOOR:**

- Carpet needs stretching

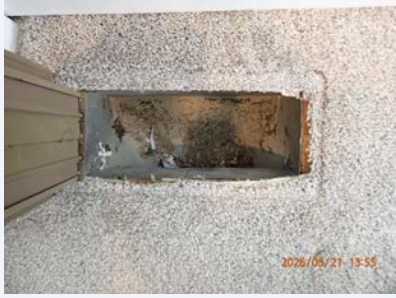
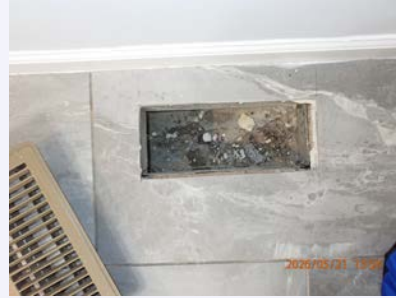
**FYI: HVAC:**

- Registers and ducts are dirty and ducts should be cleaned.

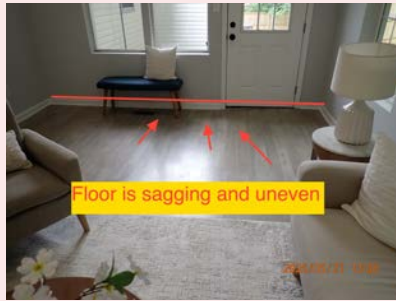
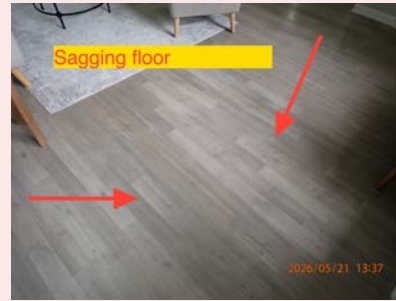
**⚠️ (LS-1) Defect/Major Concern: FLOOR:**

- Noted uneven floor
- A Qualified Contractor is recommended to evaluate and estimate repairs
- Floor is sagging.

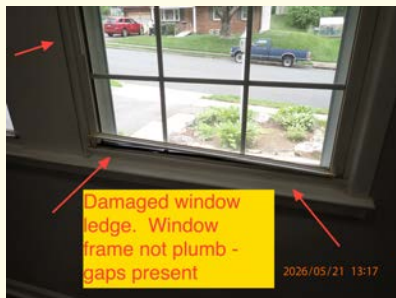
#### 🔧 (LS-2) Repair: **WINDOWS:**

- Visible damage on window framework
- Damaged frame(s)
- Recommend Repair
- Missing sealant in gaps around window frame.
- A qualified contractor is recommended to evaluate and estimate repairs

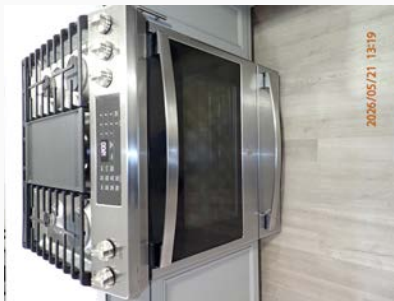
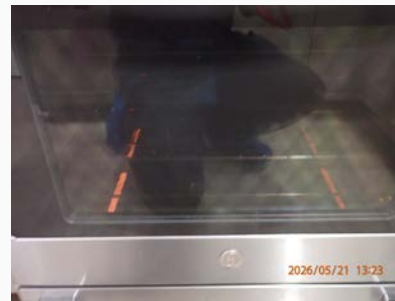
**COOKING APPLIANCE PHOTO(S):**

**⚠ (K-2) Safety/Health Hazard: COOKING APPLIANCE:**

- Stove is not installed with clearance requirements specified by the manufacturer.
- A Qualified Contractor is recommended to evaluate and estimate repairs

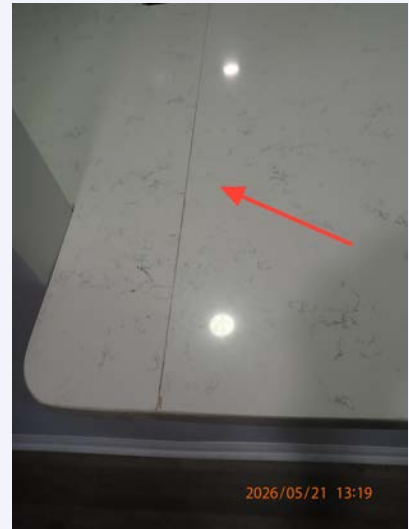
📌 FYI:

**CABINETS/COUNTER TOP:**

- Needs caulking

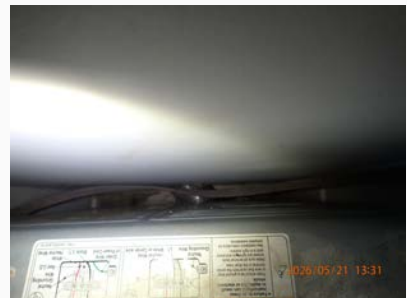
### *DRYER VENT PHOTO(s)*

- Recommend cleaning dryer ducts regularly to prevent potential fires.

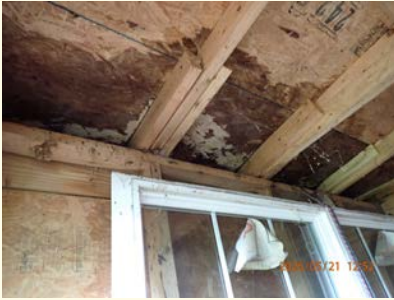
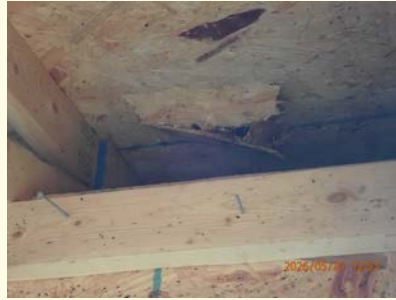
**(O1-1) Repair: OUTBUILDING ROOF:**

- Roof shows signs of deterioration

- Roof at end of useful life
- Hole in roof.

- Roof shows signs of deterioration
- Roof at end of useful life
- Hole in roof.

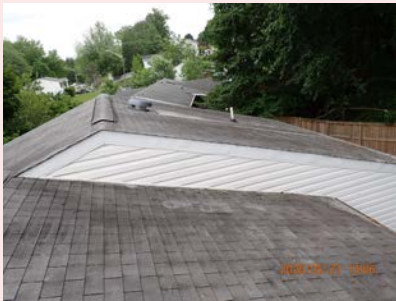
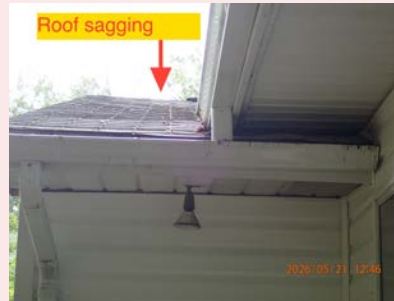
### ⚠️ **R-1 ROOF: ROOF SURFACE:**

- Standard 3-tab asphalt shingles typically last 15 to 20 years.
- Roof spongy to walk on
- Roof at end of useful life
- Moss on roof surface, This causes damage to shingles, Recommend removal or professional cleaning
- A qualified roofing contractor is recommended to evaluate and estimate repairs
- Loose or damaged shingles
- Replacement is recommended before closing

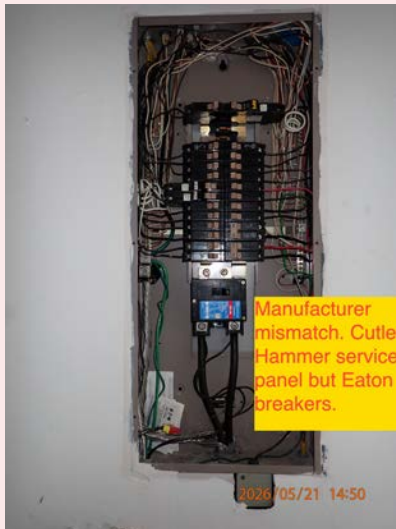
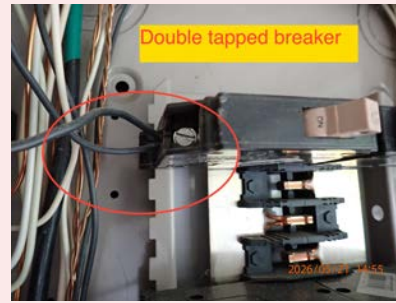
### ⚠️ **EP-1 ELECTRIC PANEL: BREAKERS:**

- Double taps are present (multiple wires in one breaker). These wires need to be moved to their own circuit breaker, Recommended evaluation and repair by a licensed electrician
- Double tap wiring

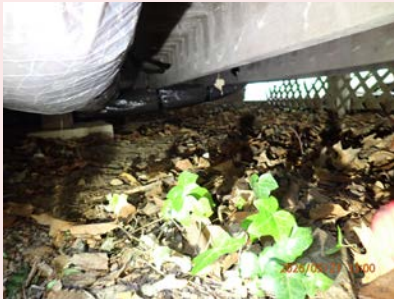
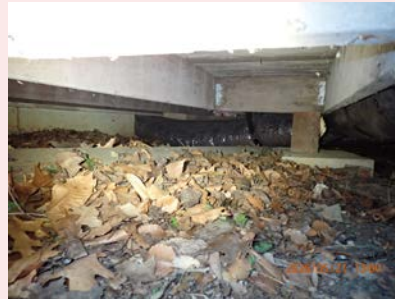
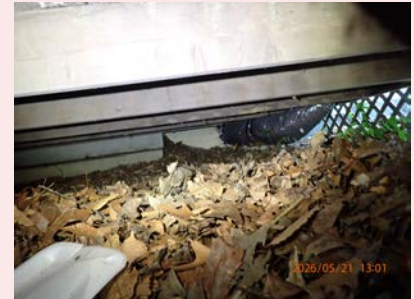
**⚠ S-1 STRUCTURE: JOIST/TRUSSES:**

- Floor in covered deck/living room area is sagging.
- Limited visibility of floor joists
- A Qualified Contractor is recommended to evaluate and estimate repairs

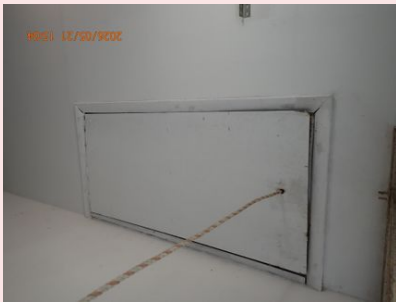
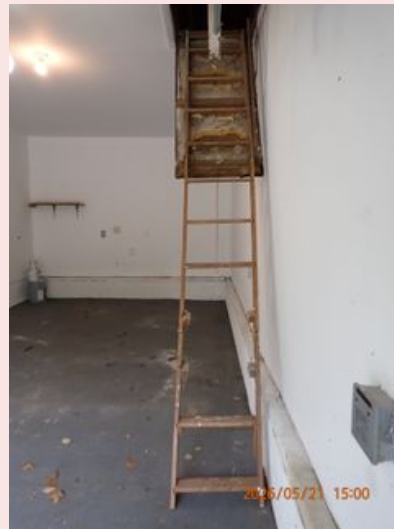
**⚠️ A-2 ATTIC:** Attic access in garages should be made of fire rated material such as drywall, repairs are recommended.

Attic access stairs are broken and require replacement.

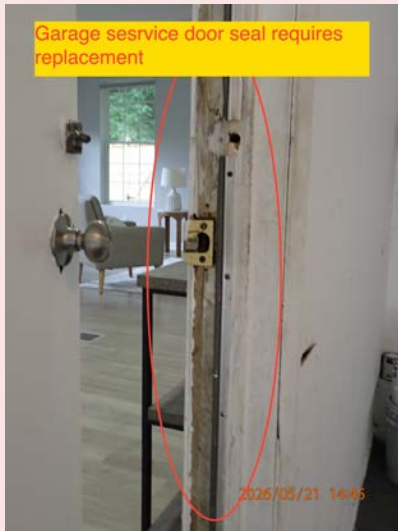
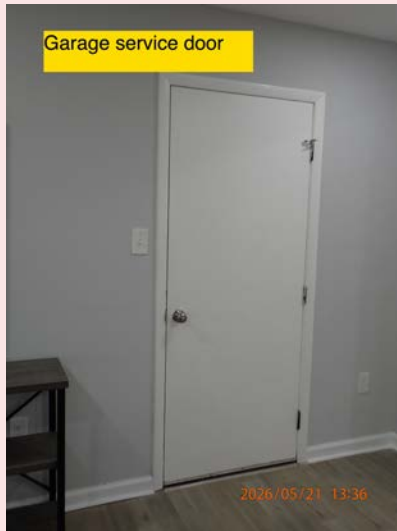
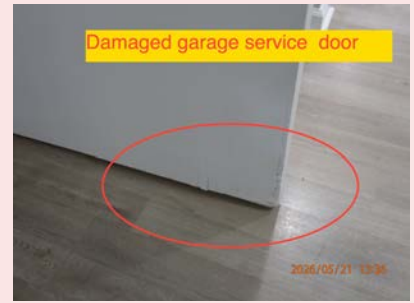
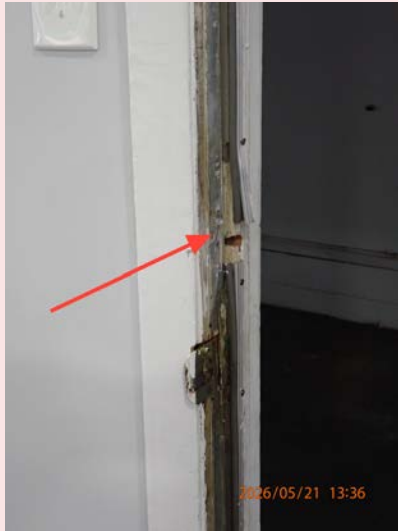
- Early stage water damage on door trim
- Missing and/or damaged door seals
- Repair Recommended

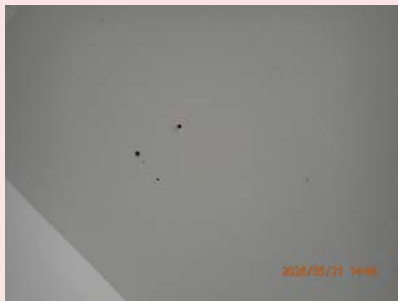
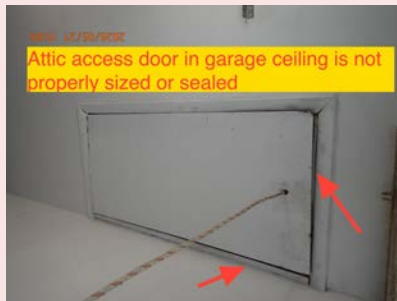
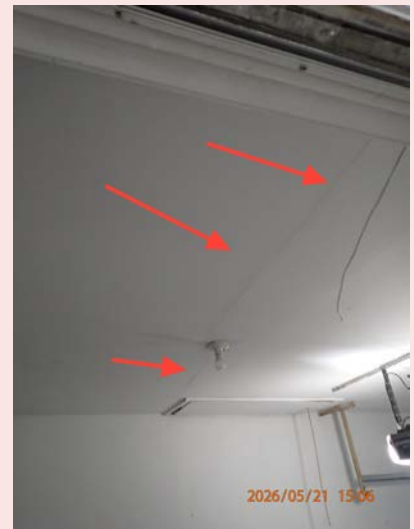
**⚠ G-2 GARAGE/CARPORT:** Penetrations are recommended to be sealed with fire rated sealant, repairs are recommended

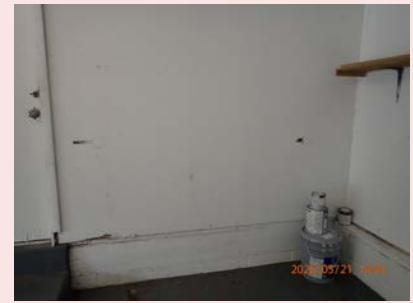
**⚠️ G-3 GARAGE/CARPORT:**

**GARAGE WALLS:**

- Holes present
- Repair Recommended
- Penetrations not sealed creating a fire hazard.

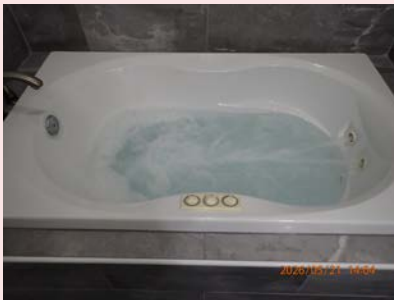
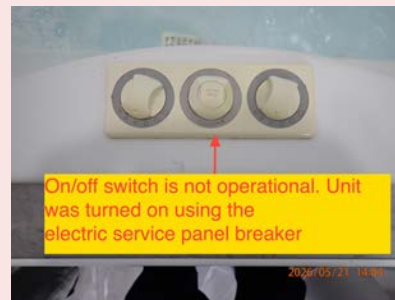
**⚠️ B2-1 BATHROOM: SPA TUB:**

- No visible access panel
- On/off switch is not operating correctly.

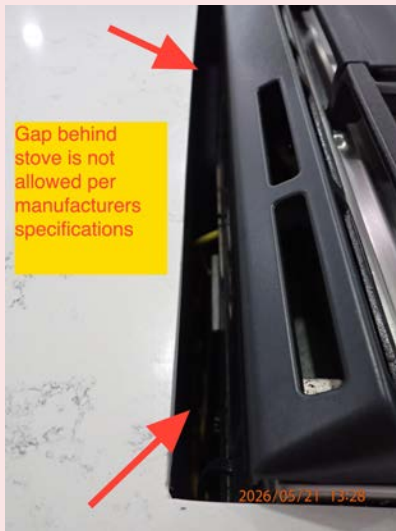
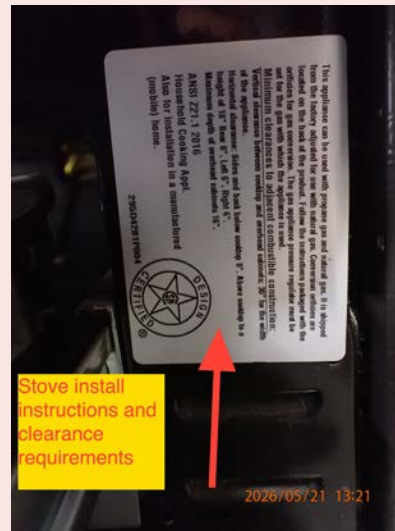
**⚠️ K-2 KITCHEN: COOKING APPLIANCE:**

- Stove is not installed with clearance requirements specified by the manufacturer.
- A Qualified Contractor is recommended to evaluate and estimate repairs

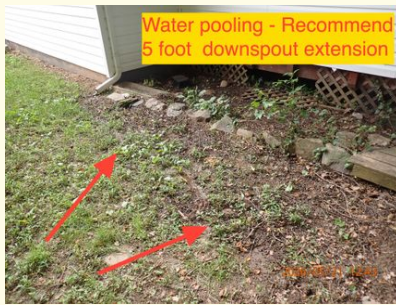
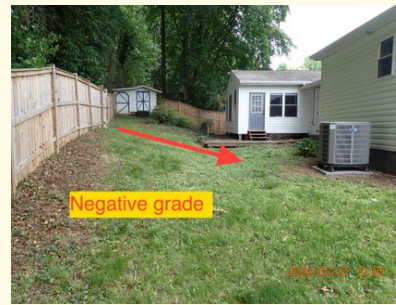
**🔧 LAG-1 LOTS AND GROUNDS: NEGATIVE GRADE:**

- Water from downspout pooling next to house
- Recommend improving grading to allow water to flow away from home by ensuring surface drainage is diverted to a storm sewer conveyance or other approved point of collection that does not create a hazard to the dwelling unit. It is recommended that lots be graded to drain surface water away from foundation walls. The grade should fall a minimum of 6 inches (152 mm) within the first 10 feet (3048 mm).
- Grading is allowing water to flow to crawlspace at rear of home

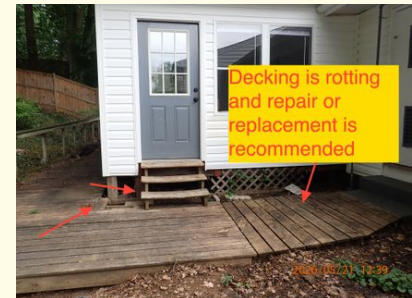
**✂ LAG-2 LOTS AND GROUNDS: DECK RAILS AND STEPS:**

- Open stair risers present. For improved safety, recommend corrections to not allow passage of a 4-inch diameter sphere
- Recommend adding rail for safety
- Repair recommended

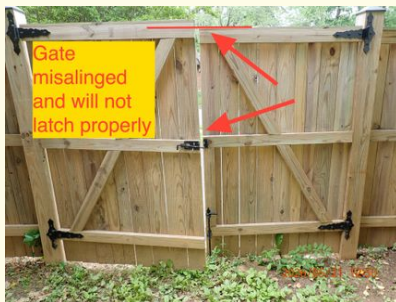
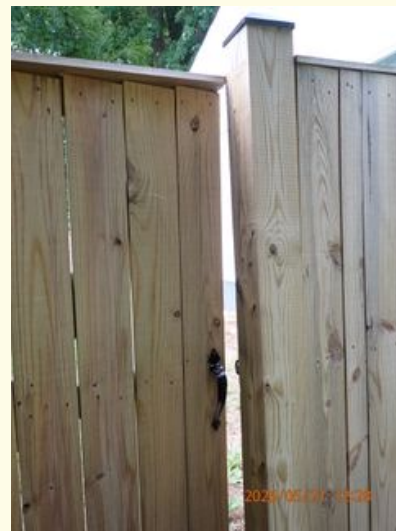
**✂ LAG-3 LOTS AND GROUNDS: FENCE:**

- Gate misaligned and will not latch properly.

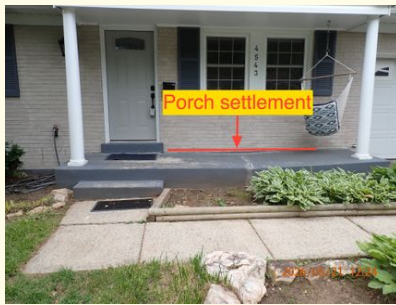
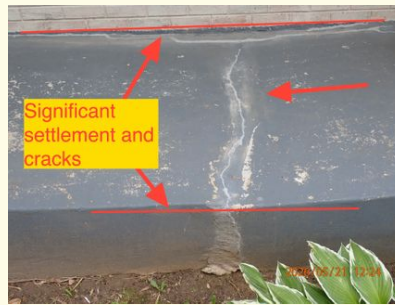
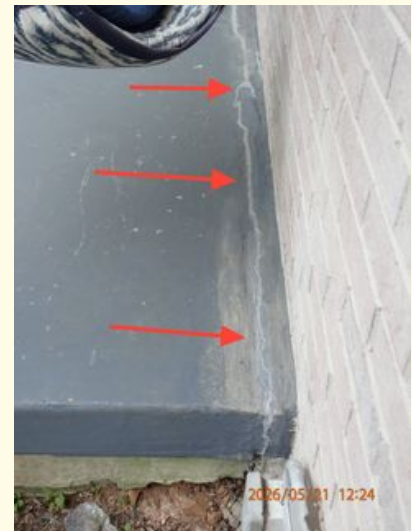
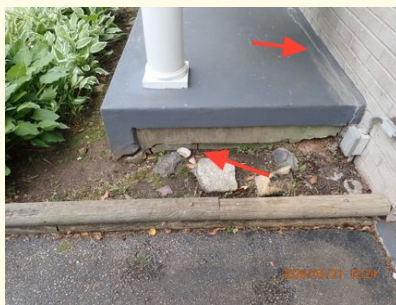
**✂ LAG-4 LOTS AND GROUNDS: PORCH/STEPS:**

- Settlement noted
- Heavily cracked
- Repair recommended

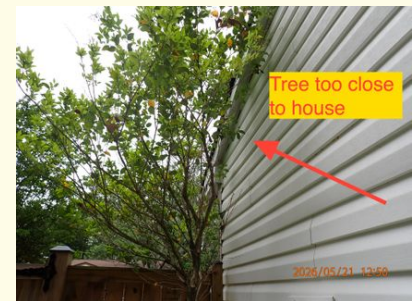
**✂ LAG-5 LOTS AND GROUNDS:**  
**TREES AND VEGETATION:**

- Tree planted too near the foundation and roots may cause damage to the foundation
- Trees planted too close to structure, removal may be required

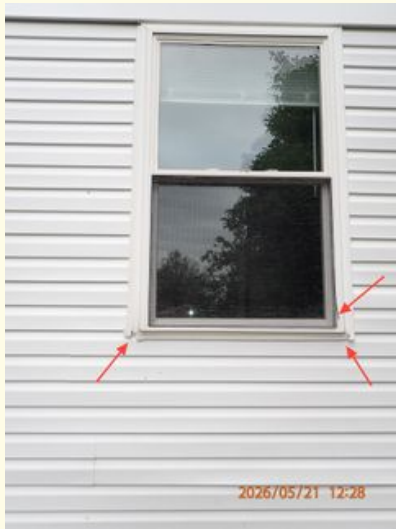
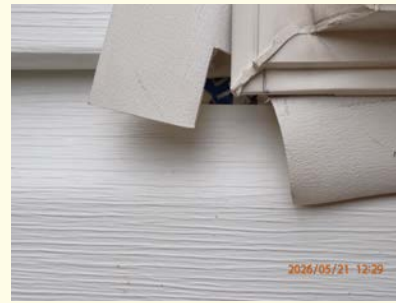
**✂ E1-1 EXTERIOR: WINDOWS:**

- Visible damage on window framework
- A qualified contractor is recommended to evaluate and estimate repairs

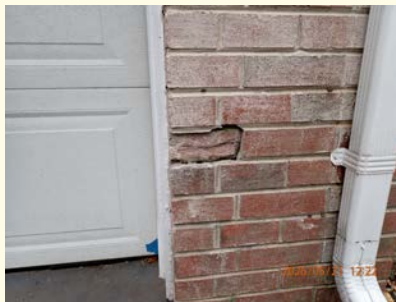
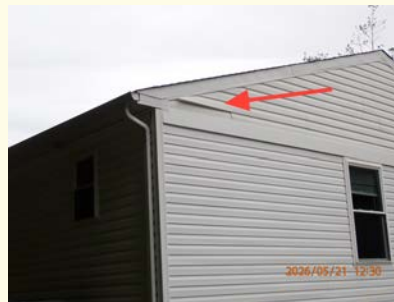
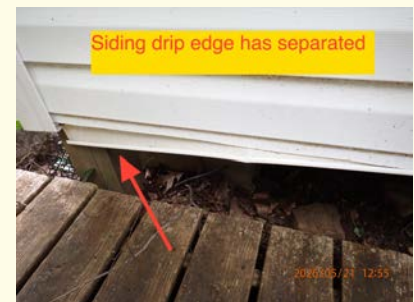
### **E1-3 EXTERIOR: SIDING:**

- Cracks present
- Repair recommended
- Loose vinyl on side of home, Recommend repair

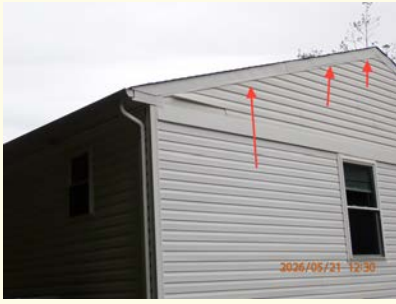
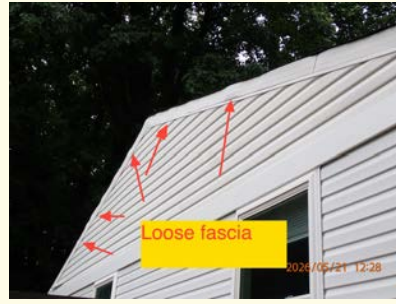
### **E1-4 EXTERIOR: FASCIA:**

- Repairs Recommended
- Loose

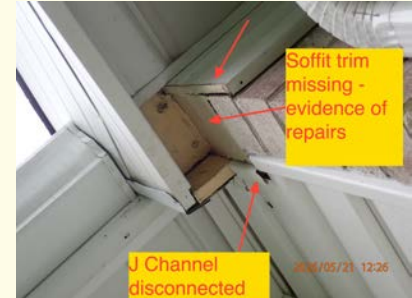
**E1-5 EXTERIOR:  
SOFFITS:**

- Damaged
- Missing trim
- Repairs Recommended

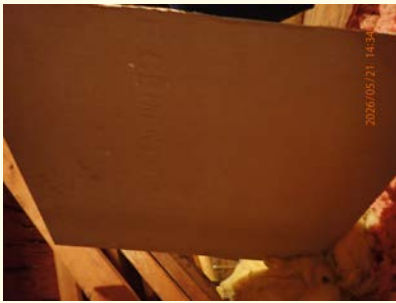
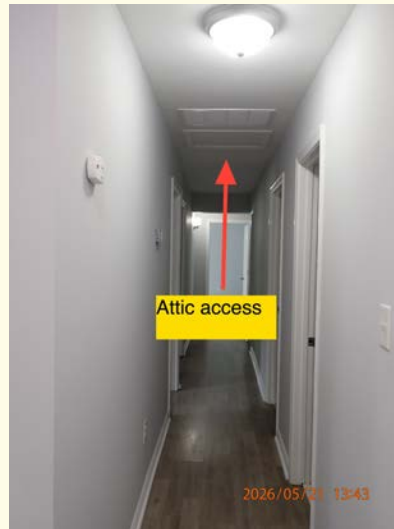
**A-6 ATTIC: ATTIC ACCESS:**

- Attic hatch made of cement board. Replace with gypsum board or OSB.
- Attic hatch missing insulation on top and gaskets around seal.

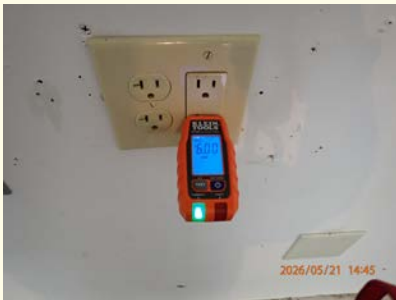
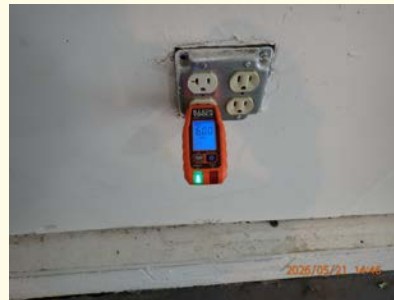
**G-5 GARAGE/CARPORT: GARAGE ELECTRICAL:**

- Non-GFCI circuit, Recommend installing GFCI protected outlet

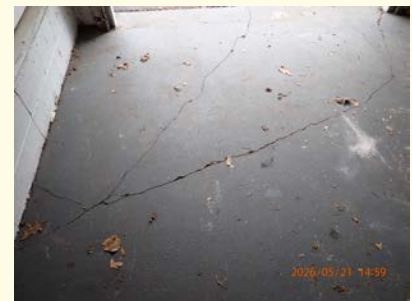
**G-6 GARAGE/CARPORT: GARAGE FLOOR:**

- Cracks present
- A Qualified Contractor is recommended to evaluate and estimate repairs

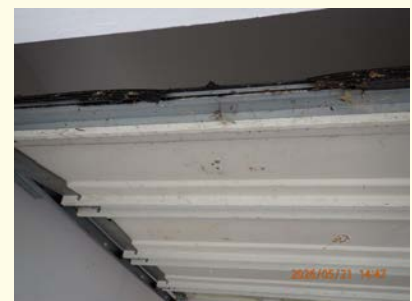
**G-7 GARAGE/CARPORT: GARAGE DOORS:**

- Weather seal damaged

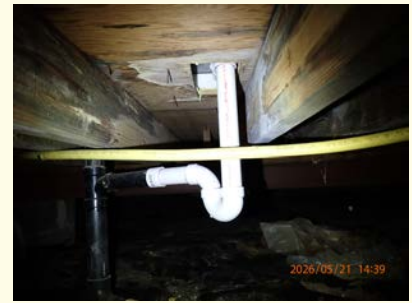
**S-2 STRUCTURE:**  
**SUBFLOOR:**

- Moisture damage under washing machine area

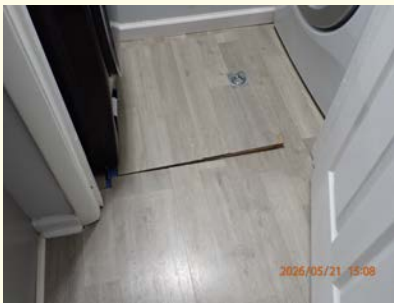
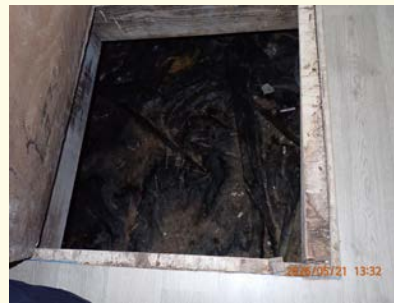
**CS-1 CRAWL SPACE: CRAWL SPACE ACCESS:**

- Access hatch is not properly sized and will not close.
- Tripping/fall hazard.
- Recommend repairs

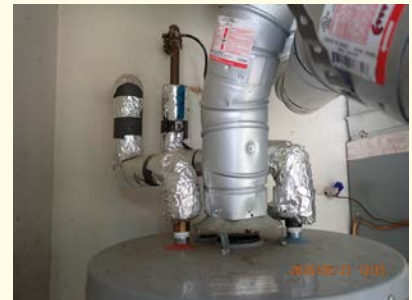
**WH-1 WATER HEATER:**  
**EXPANSION TANK:**

- Recommend adding expansion tank

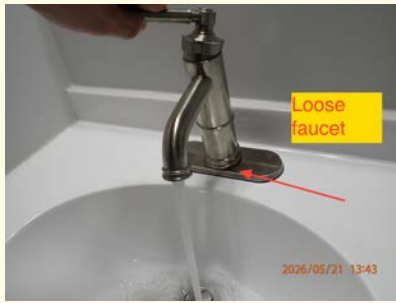
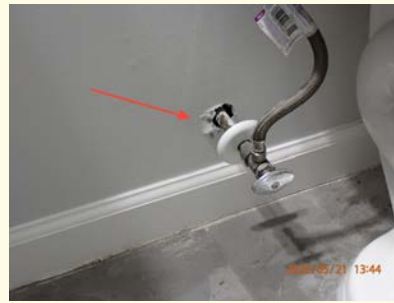
**B2-3 BATHROOM: FAUCET/TRAP:**

- Surface rust on trap
- Faucet loose.
- Supply line not secured
- Unsealed wall penetration

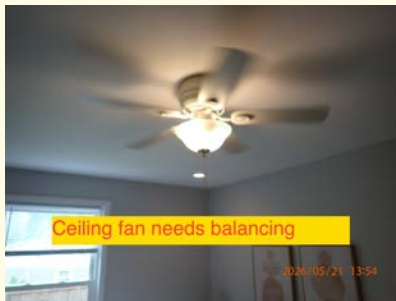
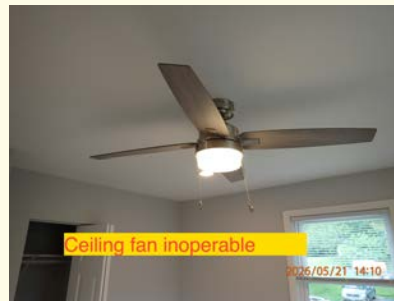
**✂ B-2 BEDROOM: ELECTRICAL:**

- Ceiling fan needs balancing
- Ceiling fan inoperative, Possible hidden remote, Recommend having operational at walk through

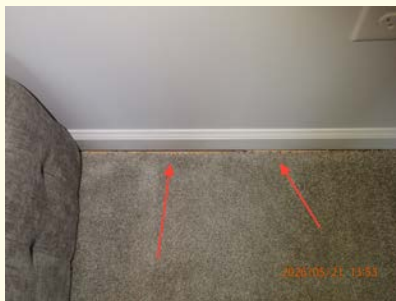
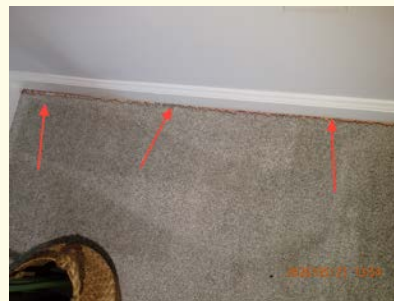
**✂ B-3 BEDROOM: FLOOR:**

- Carpet needs stretching

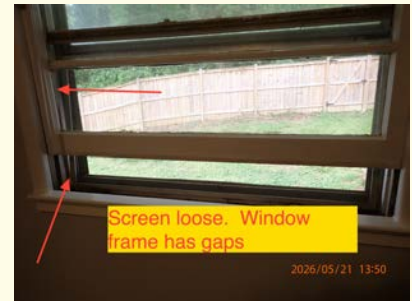
**✂ B-4 BEDROOM:**  
**WINDOWS:**

- Visible damage on window framework
- Recommend Repair

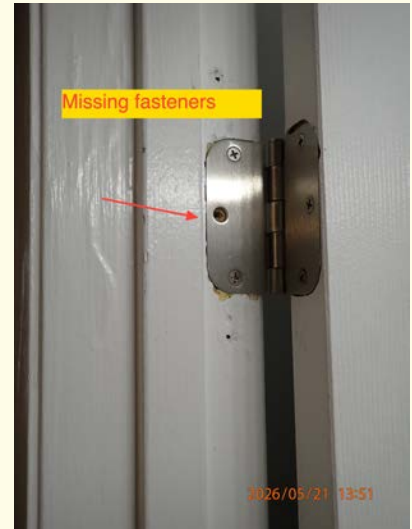
**✂ B-5 BEDROOM:**  
**DOOR:**

- Missing fasteners.

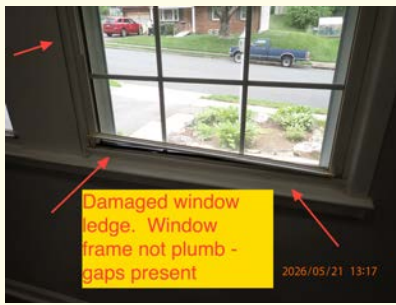
**✂ LS-2 LIVING SPACE: WINDOWS:**

- Visible damage on window framework
- Damaged frame(s)
- Recommend Repair
- Missing sealant in gaps around window frame.
- A qualified contractor is recommended to evaluate and estimate repairs
