Inspection report for the property at

1300 Example Road

This report is prepared exclusively for **John Doe**
Inspected On: **01-19-2026**

73 year old two-story Colonial Revival style single-family residence, showcasing a mix of traditional American architectural elements. This was a homeowner requested maintenance inspection to identify wear and tear, safety concerns, and maintenance needs to help protect the owners investment year-round.

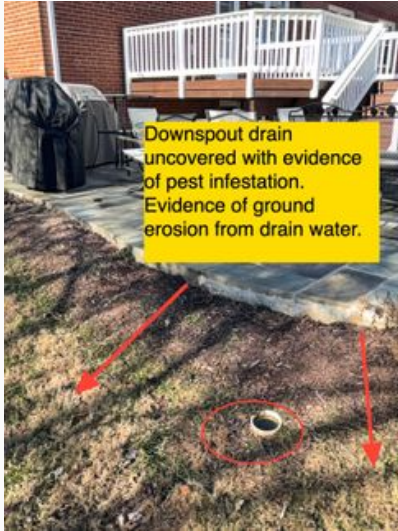
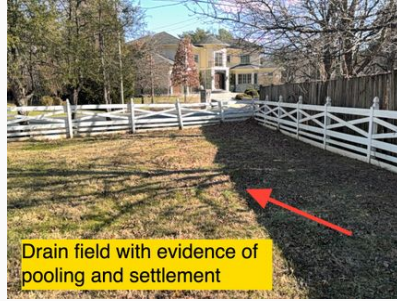
SWALE AND SURFACE DRAIN PHOTO(s):

Grading, Swale, Surface Drainage: Flat, Flat or negative slope, Pooling due to improper drainage, General Photo(s), Action Item

Improve drainage to prevent further erosion and settlement. Install drain cover to prevent pest infestation.

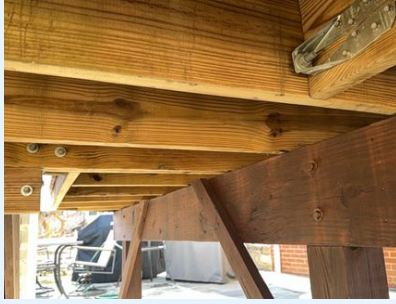
**(LAG-2) Repair: DECK:**

- Recommend further evaluation and estimate to bring deck up to an acceptable building standard.
- A qualified contractor is recommended to evaluate and estimate repairs
- Ledger board flashing missing.
- Deck appears to be attached to brick veneer and not the house band board. This could be a safety issue.

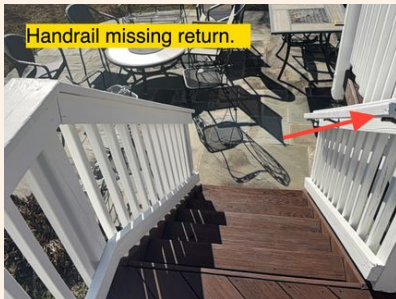
(LAG-1) Safety/Health Concern: DECK RAILS AND STEPS:

- Repair recommended

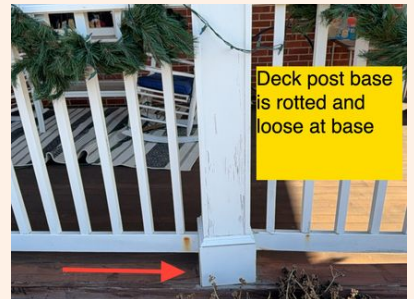
Guard rails loose

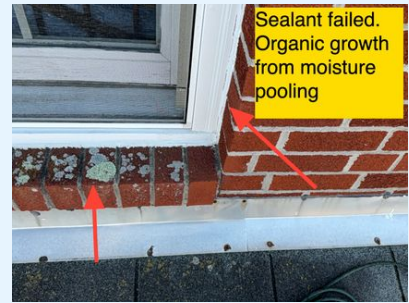
(E1-1) Repair:
WINDOWS:

- Recommend Repair
- Window sill tested positive for moisture

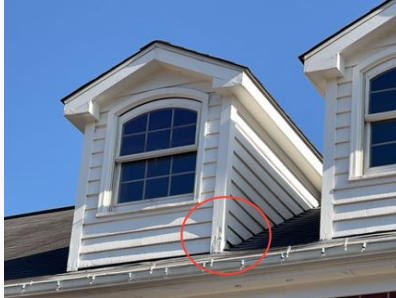
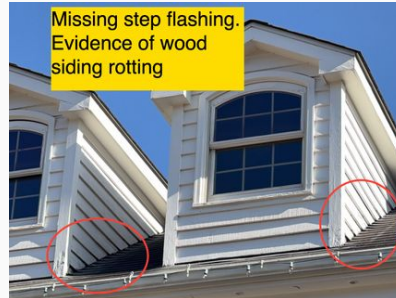
(E1-2) Repair: DORMER:

- Water damage noted on siding (See pictures for details)
- Missing Flashing
- Siding is not recommended to sit directly on roof surfaces, subject to moisture

damage

- A qualified contractor is recommended to evaluate and make necessary repairs

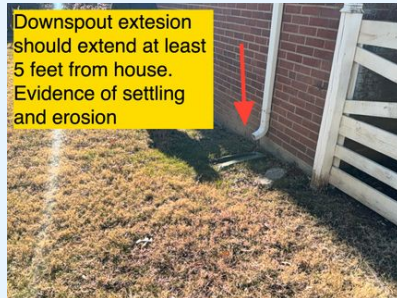
🔧 (R-2) Repair: GUTTER EXTENSIONS:

🔧 Gutter extension should extend at least 5 feet away from house to prevent water penetration and pooling against foundation. Evidence of water pooling and splashing against foundation and wall.

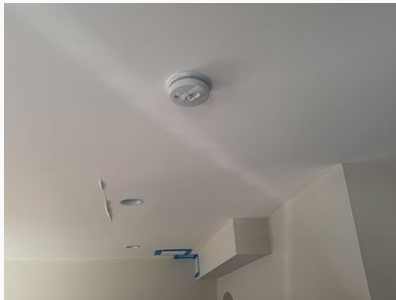
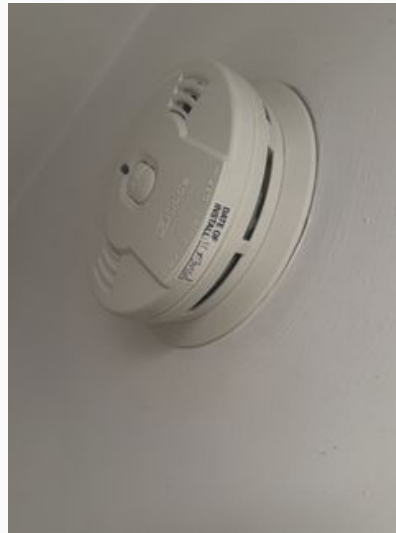
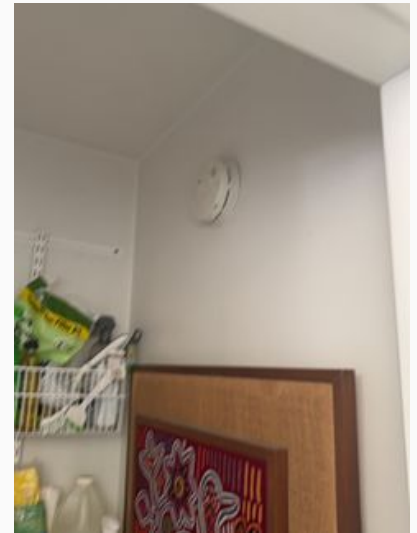
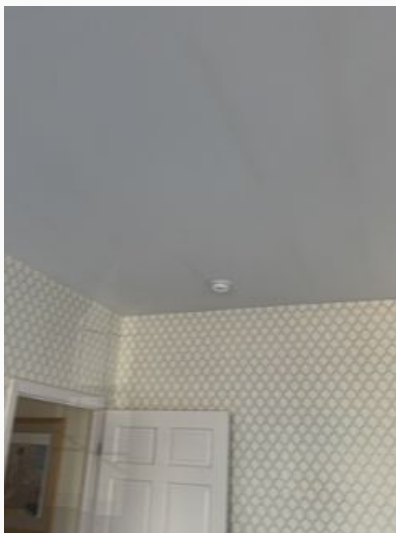
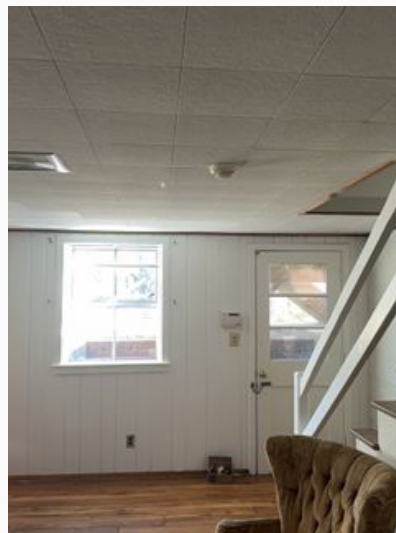
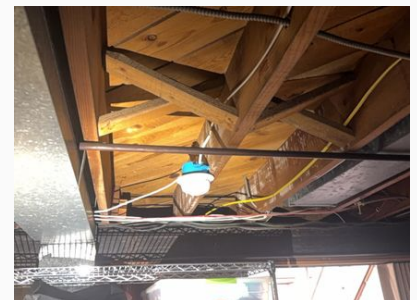
SMOKE ALARM PHOTO(S):

- Smoke alarms appear to be over 10 years old
- New Guidelines recommend replacing smoke alarms every 10 years

- It is recommended that a home have smoke alarms on each level of the dwelling and in every bedroom or sleeping area. Clients should replace any existing smoke alarms that are not in good working order with new ones and install smoke alarms where they may be missing or not properly located. Any test of a smoke alarm during a home inspection only reflects its condition at the time of inspection and is not a guarantee, warranty, or any form of insurance. A test performed during the home inspection does not supersede the smoke alarm manufacturer's testing recommendations. Clients should follow the manufacturers instructions for proper placement, installation, and maintenance.

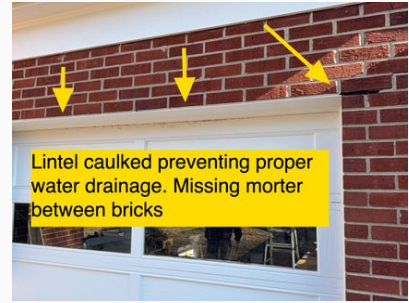
GARAGE DOOR PHOTO(S):

Garage Doors: Wood, General Photo(s), Poor Condition, Action Item

- Early stage water damage on door trim
- A qualified mason is recommended to evaluate and estimate repairs
- Lintel above door is sealed with caulk preventing proper water drainage.
- Mortar missing between bricks with evidence of water penetration

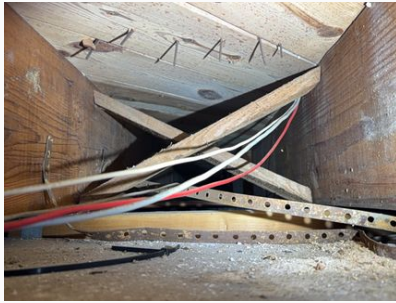
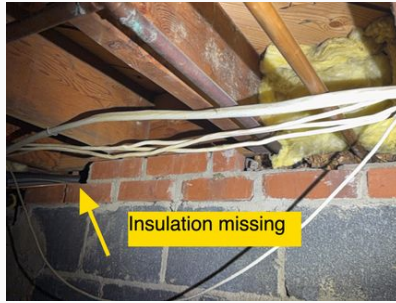
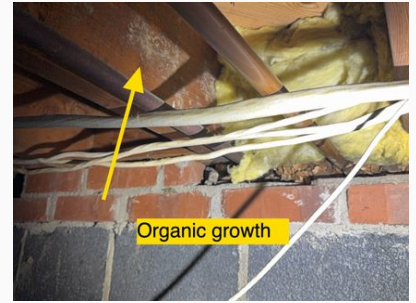
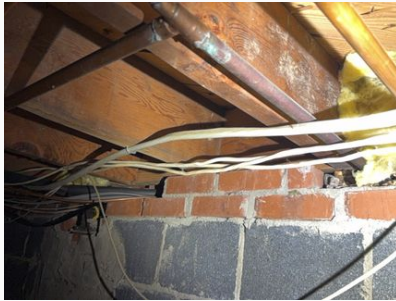
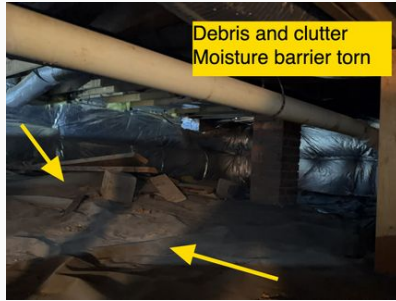
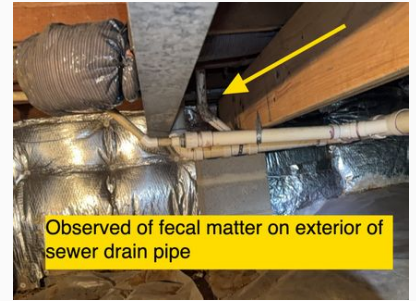
CRAWL SPACE LOCATION PHOTO(s):

Moisture Intrusion: Damp along footers

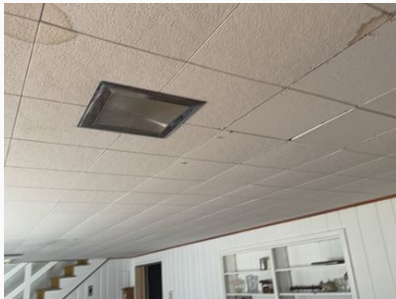
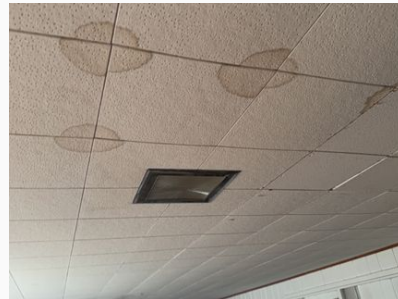
BASEMENT CEILING PHOTO(s):

Ceilings: Suspended ceiling, Stains Present, General Photo(s)

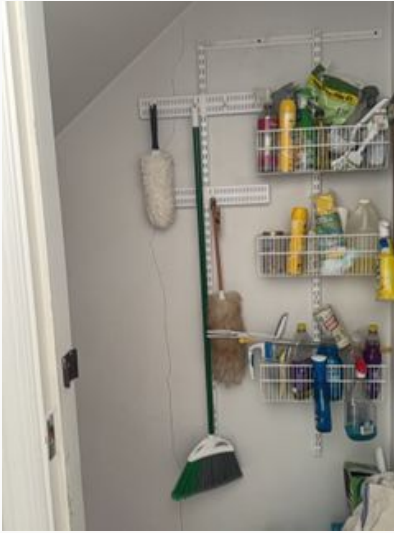
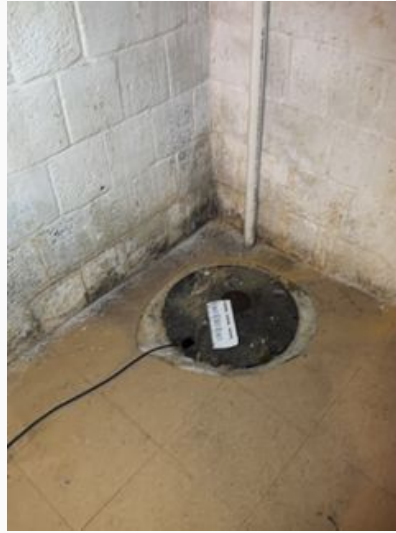
BASEMENT WALL PHOTO(s):

Walls: Paint, General Photo(s), Visible repairs noted

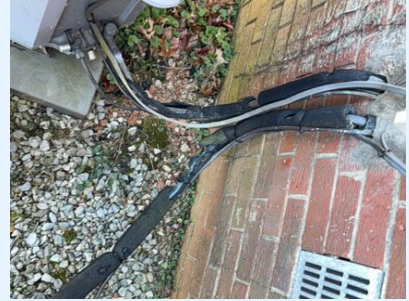
🔧 (AC-4) Repair:
REFRIGERANT LINES:

- Missing/Damaged insulation on large line can decrease efficiency, Recommend Repair

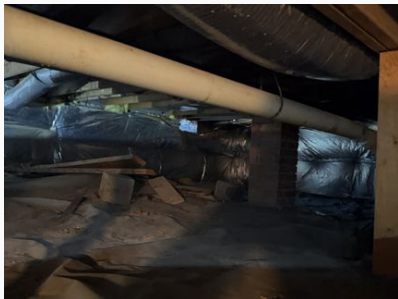
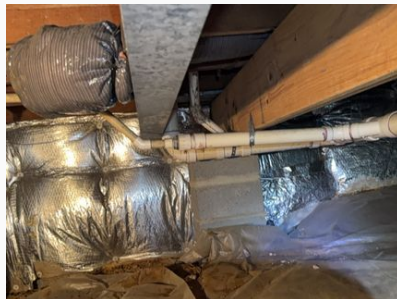
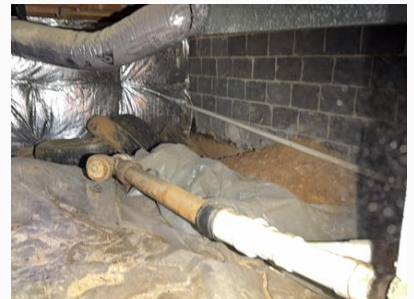
DRAIN PIPE PHOTO(s):

Drain Pipes and fixtures: PVC, General Photo(s), Cast iron

Q (P-1) Due Diligence: Cast iron drain pipes present, this material corrodes from the inside out causing debris buildup, poor operation and breaks, to assess the current condition of the pipes a qualified plumber will be needed, any operational issues noticed during the inspection will be annotated in the appropriate location of the report

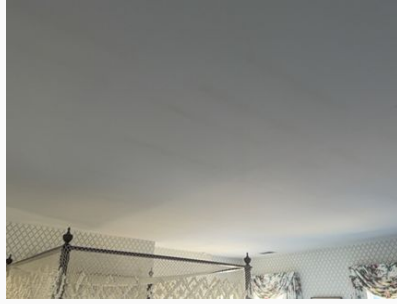
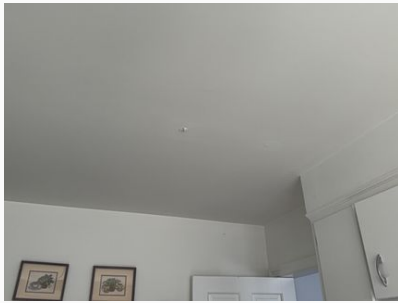
(B-1) Repair: **CEILING:**

Ceiling: Paint, Cracks present, General Photo(s), Visible repairs noted, Action Item

- Water stains present, Dry at the time of the inspection
- Visible repair
- Loose tape joint
- A Qualified Contractor is recommended to evaluate and estimate repairs

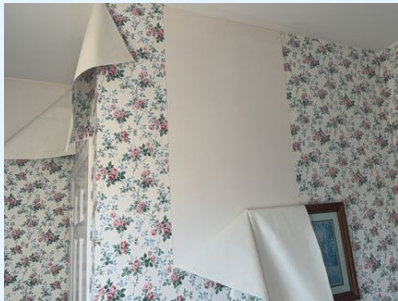
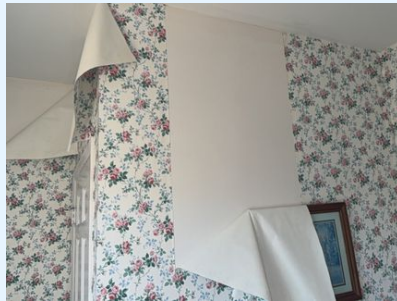
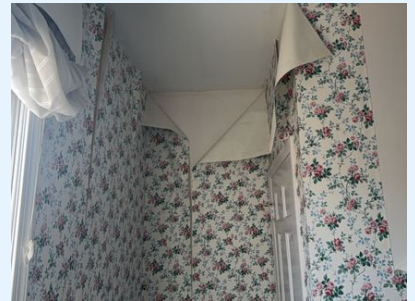
**(B-2) Repair: WALLS:**

Walls: Wallpaper, Action Item

- A Qualified Contractor is recommended to evaluate and estimate repairs
- Wallpaper peeling off and hanging loosely.

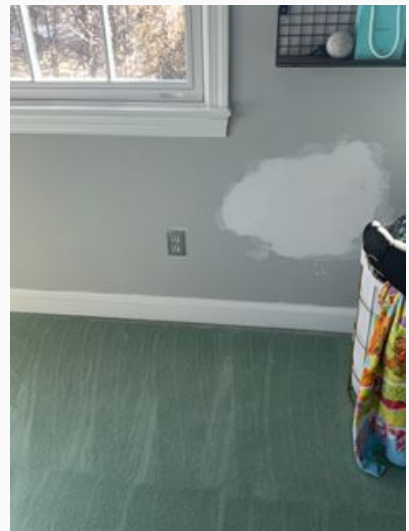
WALL PHOTO(s):

Walls: Drywall, Paint, Visible repairs noted, General Photo(s)

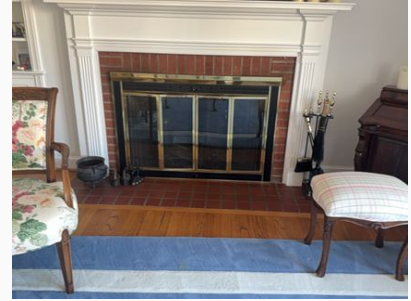
FIREPLACE LOCATION PHOTO(S):

🚩 (FFA-1) Safety/Health Concern: OXYGEN DEPLETION SENSOR:

🔧 No oxygen depletion sensor present on gas log control unit, a qualified contractor is recommended to evaluate and estimate repairs

🚩 (FFA-2) Safety/Health Concern: Ventless gas logs are not permitted to be used in bedrooms, a qualified contractor is recommended to evaluate and estimate repairs

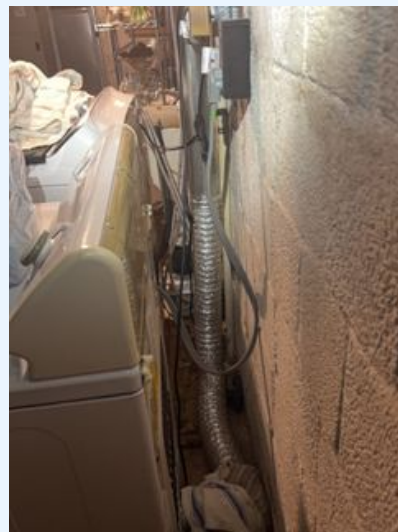
Dryer Vent: Flexible, Metal, Action Item

- Needs cleaning

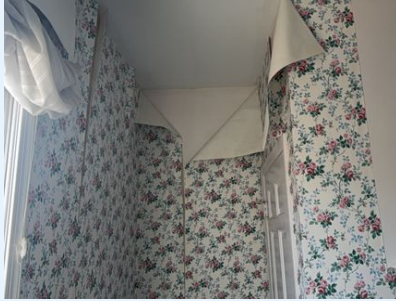
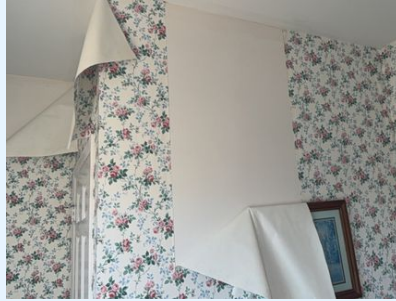
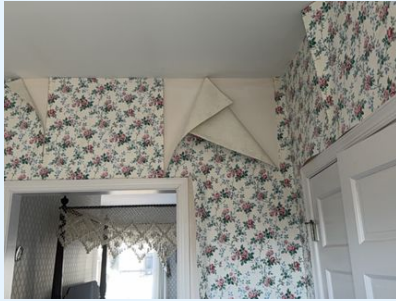
(IR-2) **Repair: WALL(s) ACTION ITEM(s):**

- Repair Recommended
- Wall paper peeling off.

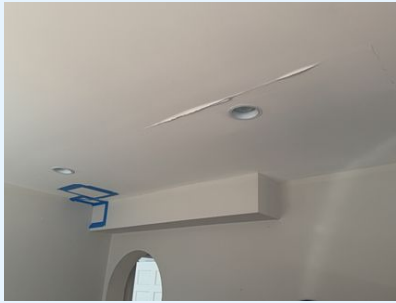
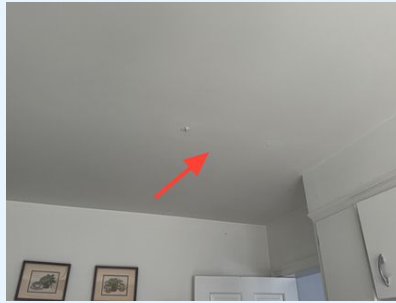
🔧 (IR-3) Repair: **CEILING:**

- Cracks present
- Visible repair
- Loose tape joint
- Water stains present, Dry at the time of the inspection
- Repair Recommended
- A Qualified Contractor is recommended to evaluate and estimate repairs

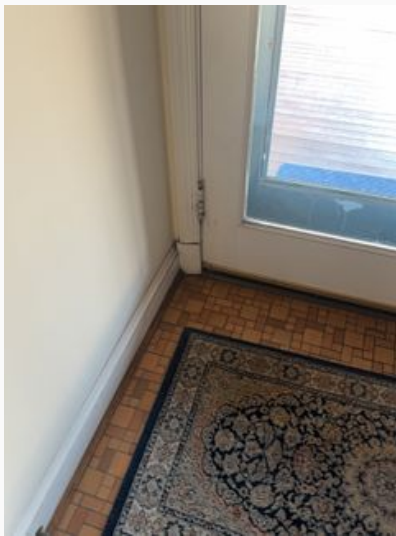
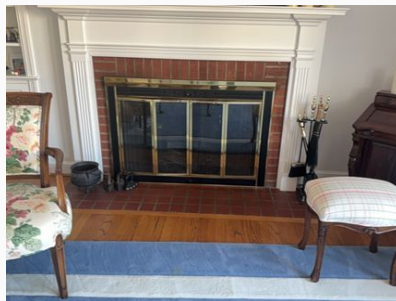
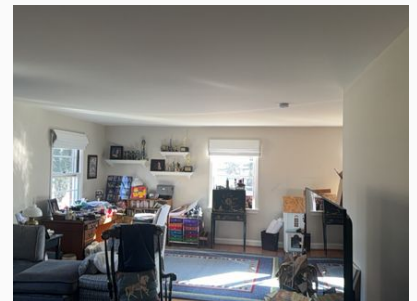
FLOOR PHOTO(s):

- A Qualified Contractor is recommended to evaluate and estimate repairs
- Repairs Recommended
- Vinyl tile floor not installed properly with gaps between planks.

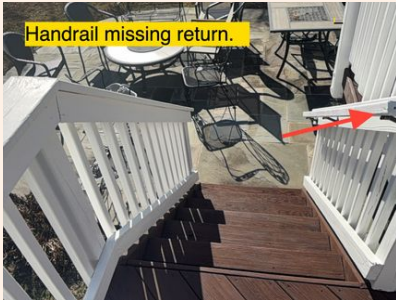
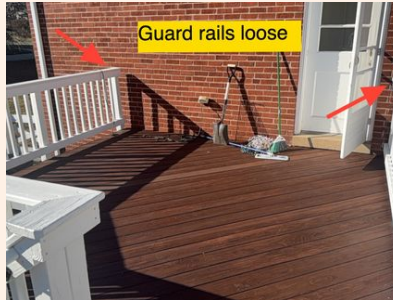
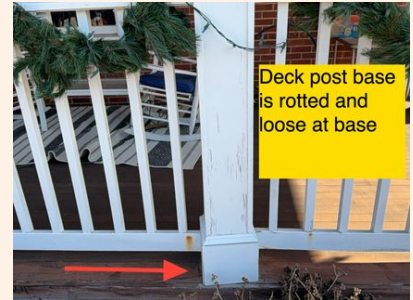
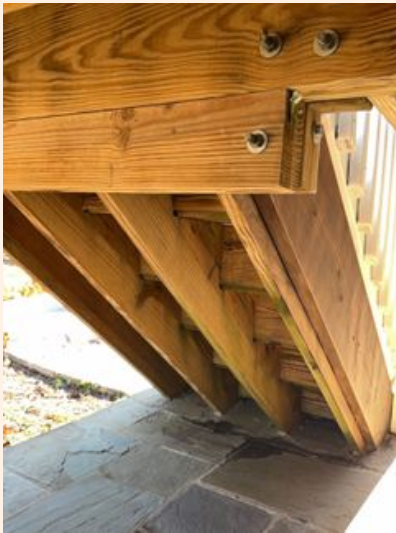
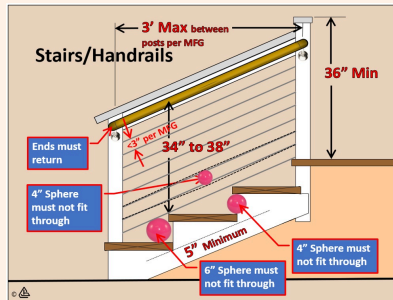
🔧 **LAG-1 LOTS AND GROUNDS: DECK RAILS AND STEPS:**

- Recommend further evaluation and estimate to bring deck up to an acceptable building standard.
- A qualified contractor is recommended to evaluate and estimate repairs
- Ledger board flashing missing.
- Deck appears to be attached to brick veneer and not the house band board. This could be a safety issue.

- Repair recommended

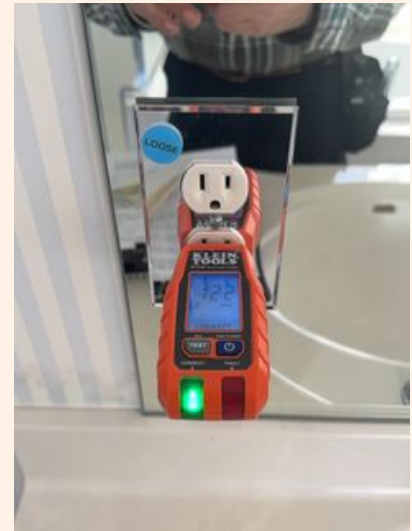
⚡ B2-1 BATHROOM:

Non GFCI protected circuit noted, A licensed electrician is recommended to evaluate and repair

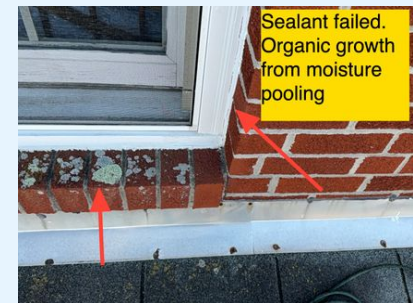
E1-1 EXTERIOR: WINDOWS:

- Recommend Repair
- Window sill tested positive for moisture

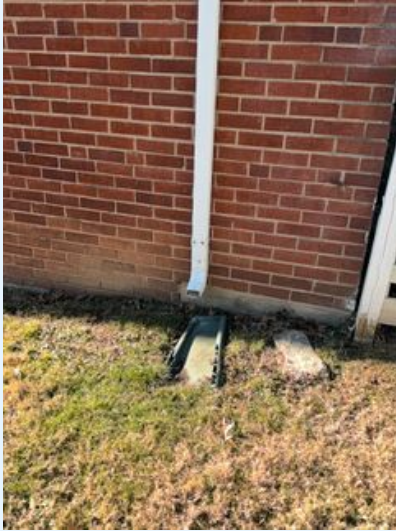
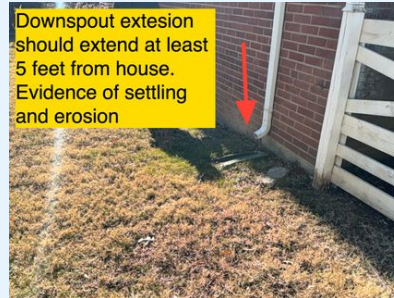
R-2 ROOF: GUTTER EXTENSIONS:

✎ Gutter extension should extend at least 5 feet away from house to prevent water penetration and pooling against foundation. Evidence of water pooling and splashing against foundation and wall.

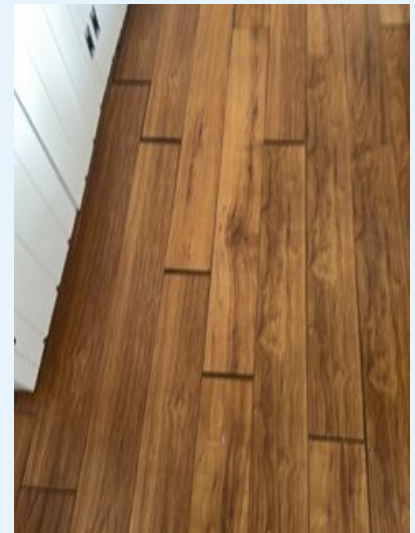
- Repairs Recommended
- A Qualified Contractor is recommended to evaluate and estimate repairs
- Flooring not installed properly with large gaps between floor planks.

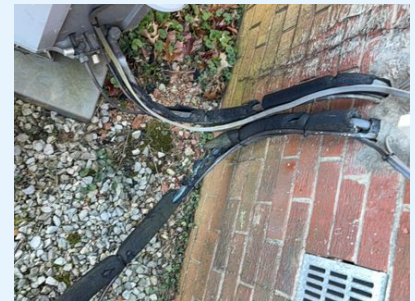
**🔧 AC-4 AIR CONDITIONING:
REFRIGERANT LINES:**

- Missing/Damaged insulation on large line can decrease efficiency, Recommend Repair

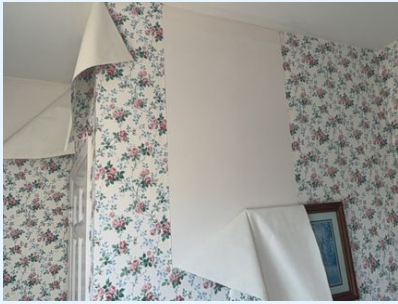
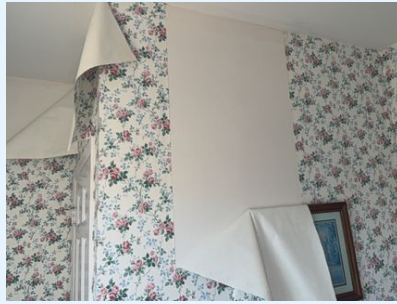
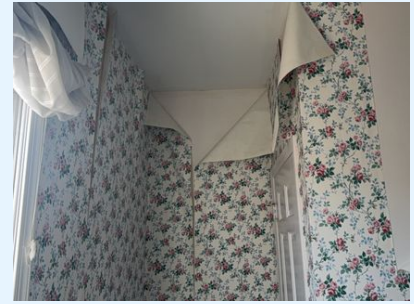
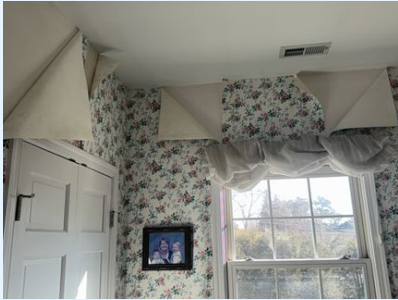
- Wallpaper peeling off and hanging loosely.

- A Qualified Contractor is recommended to evaluate and estimate repairs

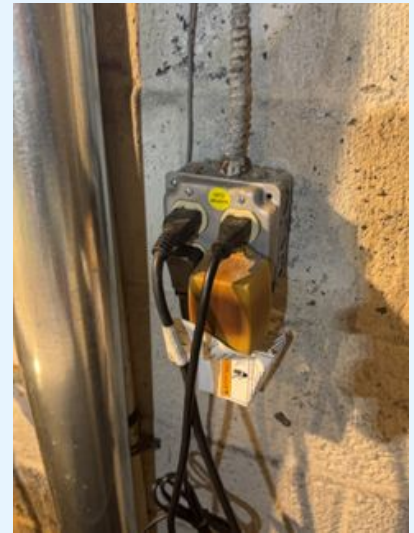
LR-1 LAUNDRY ROOM/AREA:

Non GFCI protected circuit noted, A licensed electrician is recommended to evaluate and repair

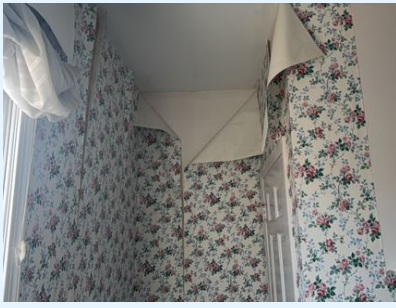
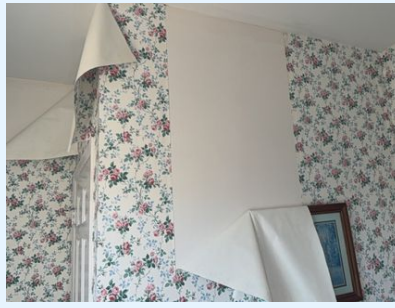
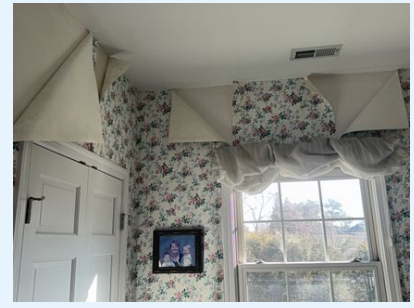
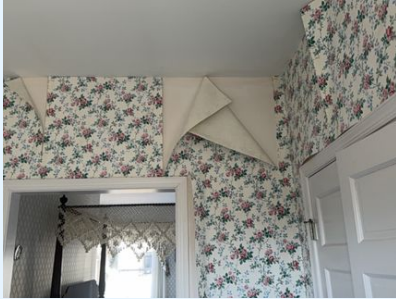
IR-2 INTERIOR RESIDENTIAL: WALL(S) ACTION ITEM(S):

- Repair Recommended
- Wall paper peeling off.

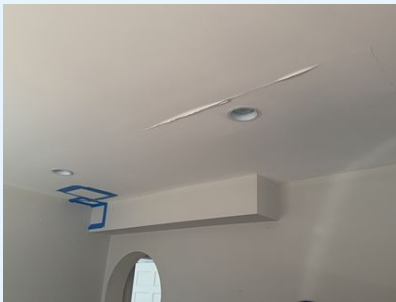
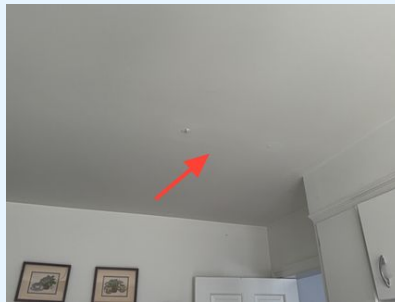
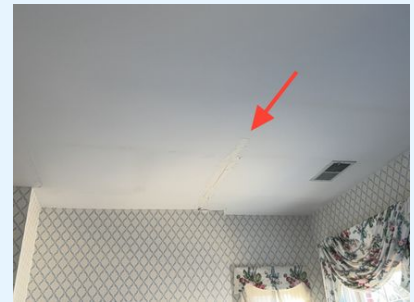
IR-3 INTERIOR RESIDENTIAL: CEILING:

- Cracks present
- Visible repair
- Loose tape joint
- Water stains present, Dry at the time of the inspection
- Repair Recommended
- A Qualified Contractor is recommended to evaluate and estimate repairs

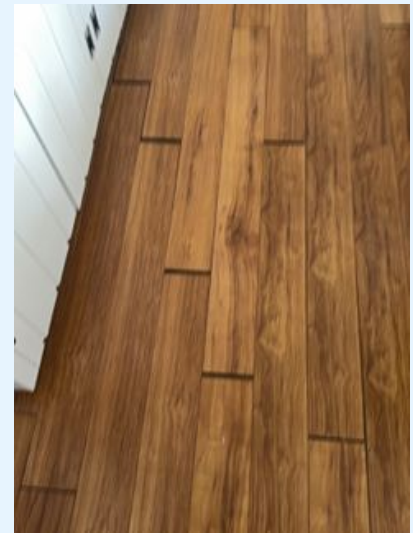
IR-4 INTERIOR RESIDENTIAL: FLOOR:

- A Qualified Contractor is recommended to evaluate and estimate repairs
- Repairs Recommended
- Vinyl tile floor not installed properly wth gaps between planks.

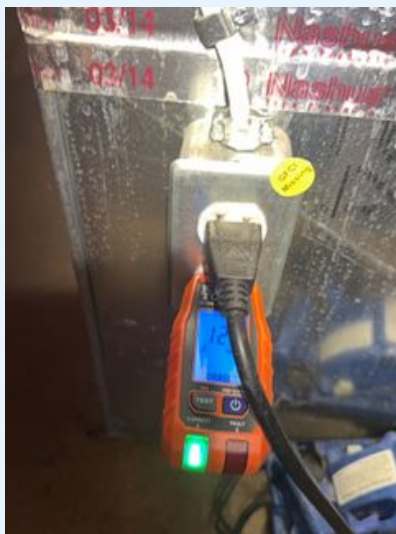
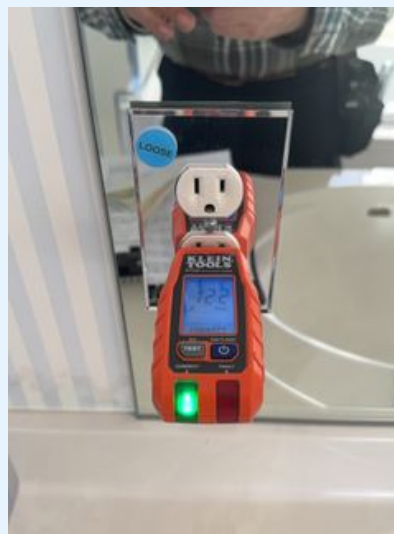
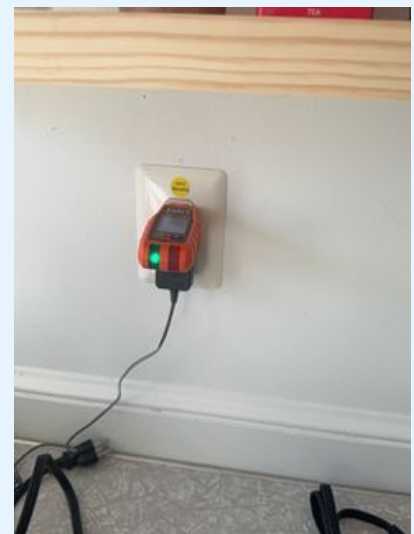
IR-5 INTERIOR RESIDENTIAL: INTERIOR ELECTRICAL OUTLETS AND LIGHTS; ACTION ITEMS:

- Non-GFCI circuit, Recommend installing GFCI protected outlet
- Two prong outlet(s) present (Non grounded), typical for age of home
- Recommend evaluation by licensed electrician and estimate repairs
